# Jason Creek (Reid Road) Assessment

**Presented by:** Dr. Matthias Jakob, P.L.Eng., P.Geo., Lauren Hutchinson, M.Sc., P.Eng.

**Client:** Squamish-Lillooet Regional District

**Date:** March 26, 2022

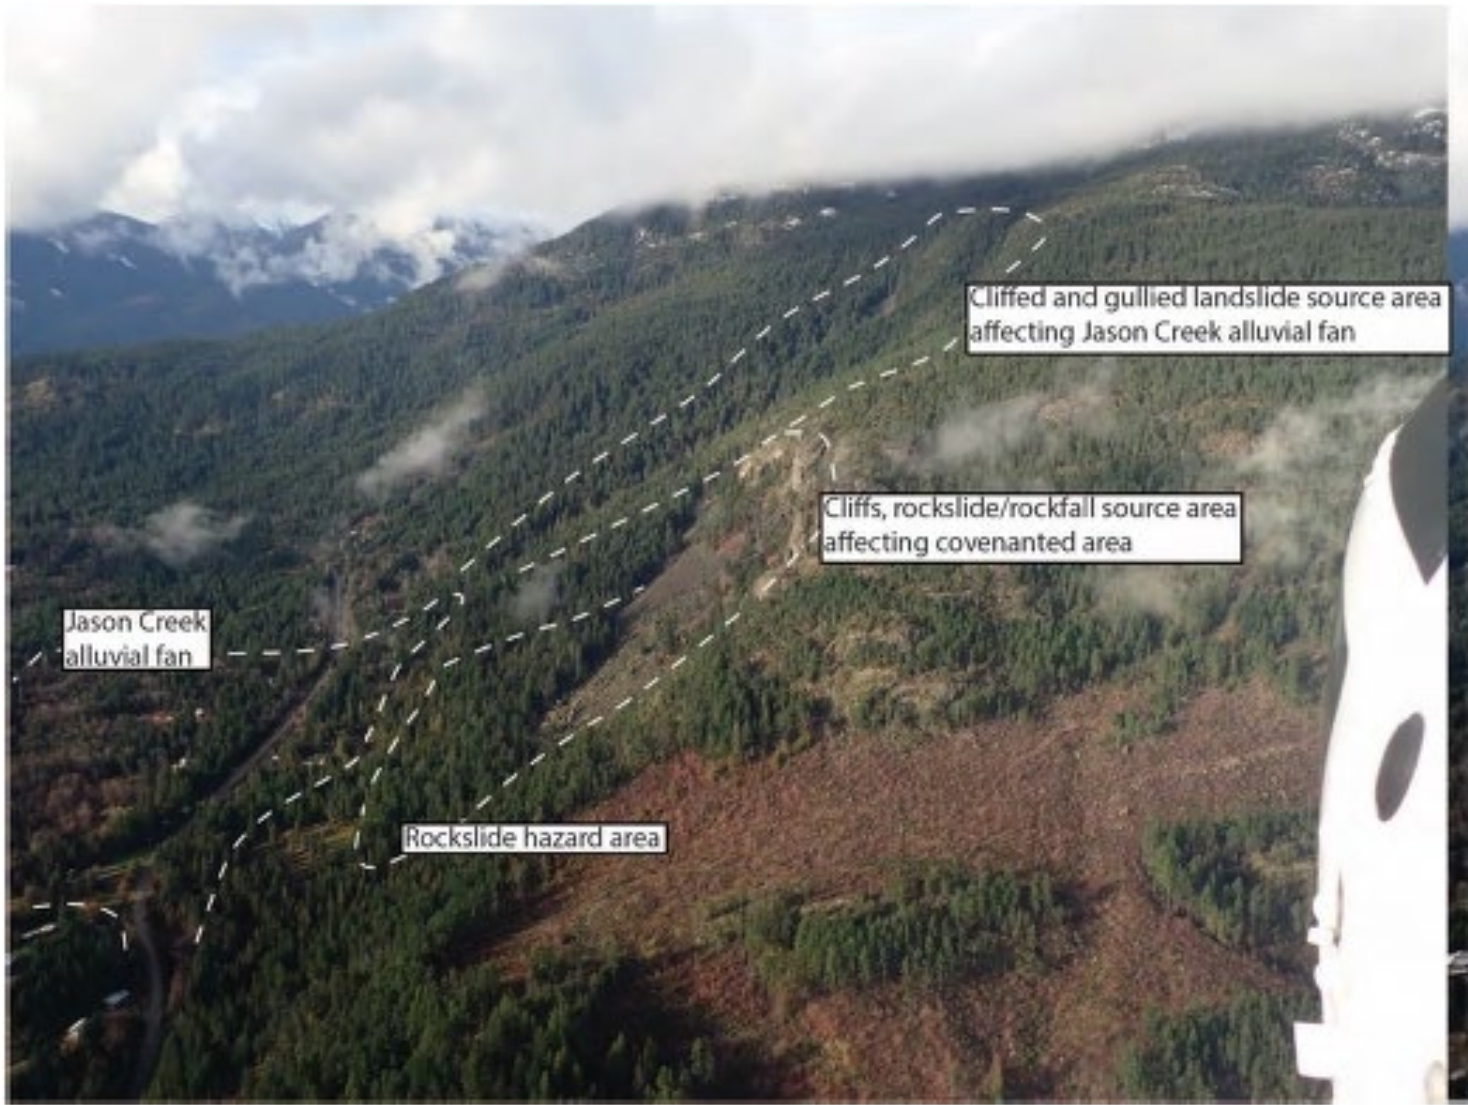
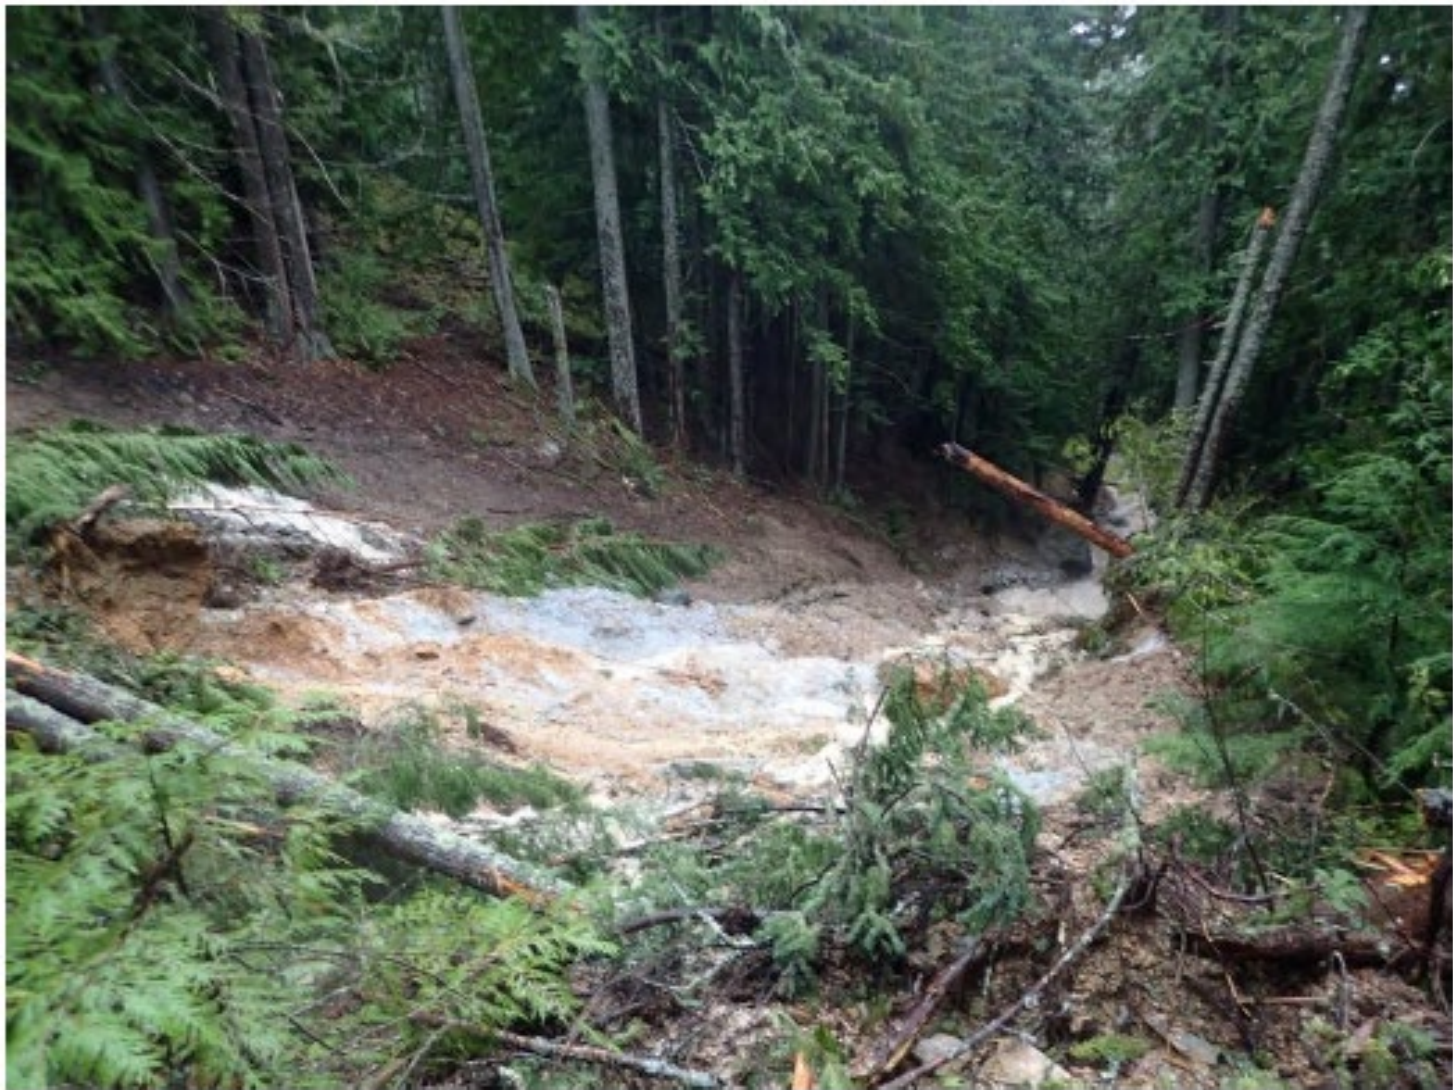
Cordilleran (December 13, 2021)

# In the Jason Creek watershed, there are steep slopes with evidence of failures (debris-flow source areas).

**Jason Creek watershed is subject to a range of hazard types, including rock slope failures and debris flows.**  
 Additional work is required to assess potential failure volumes, probabilities, and magnitudes.

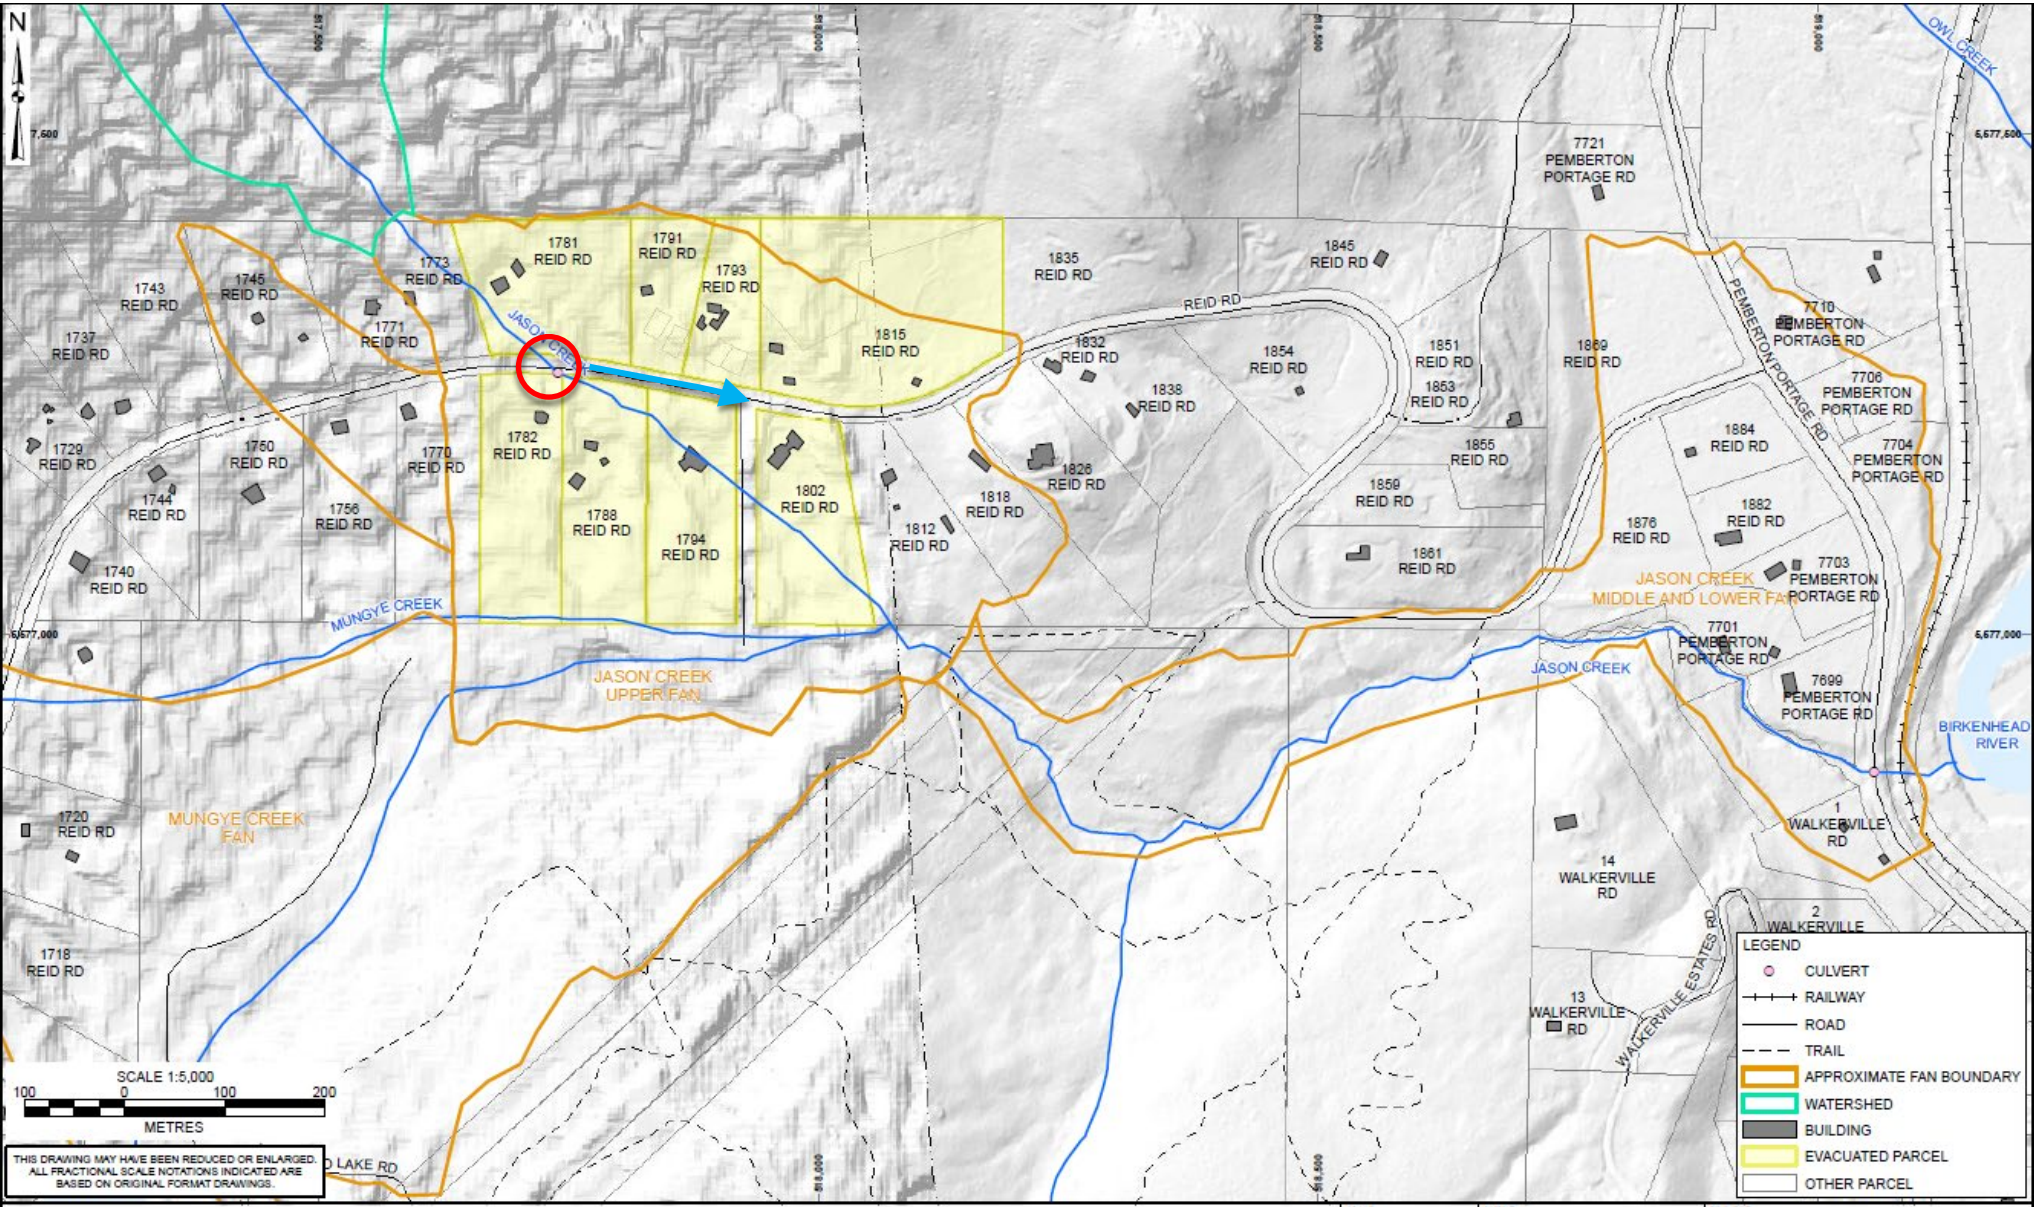
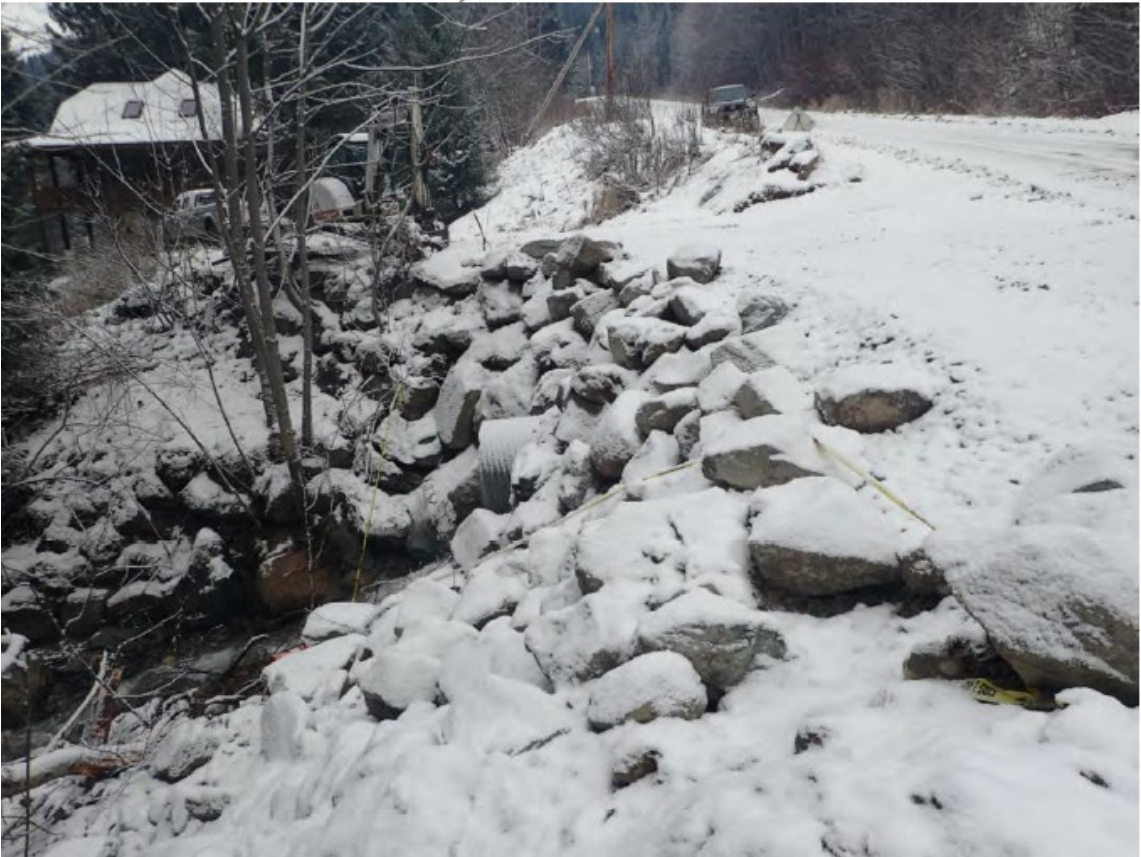
Reid Road Culvert (December 12, 2021)  
Cordilleran (December 13, 2021)

# The alignment of Reid Road increases the likelihood of flow along the road and associated downstream impacts.

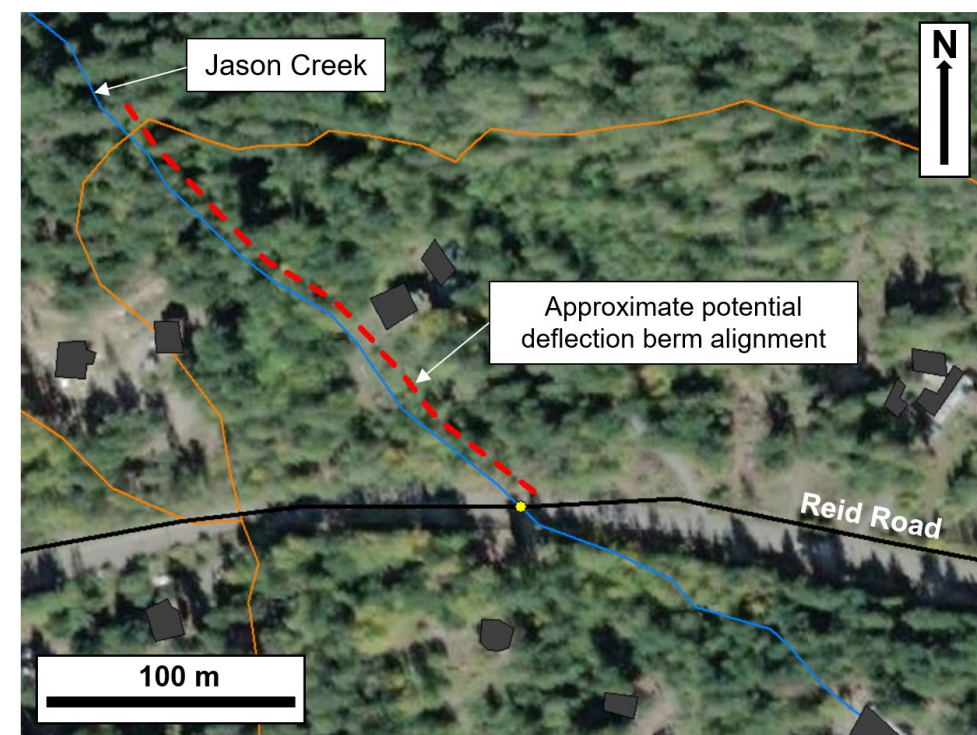
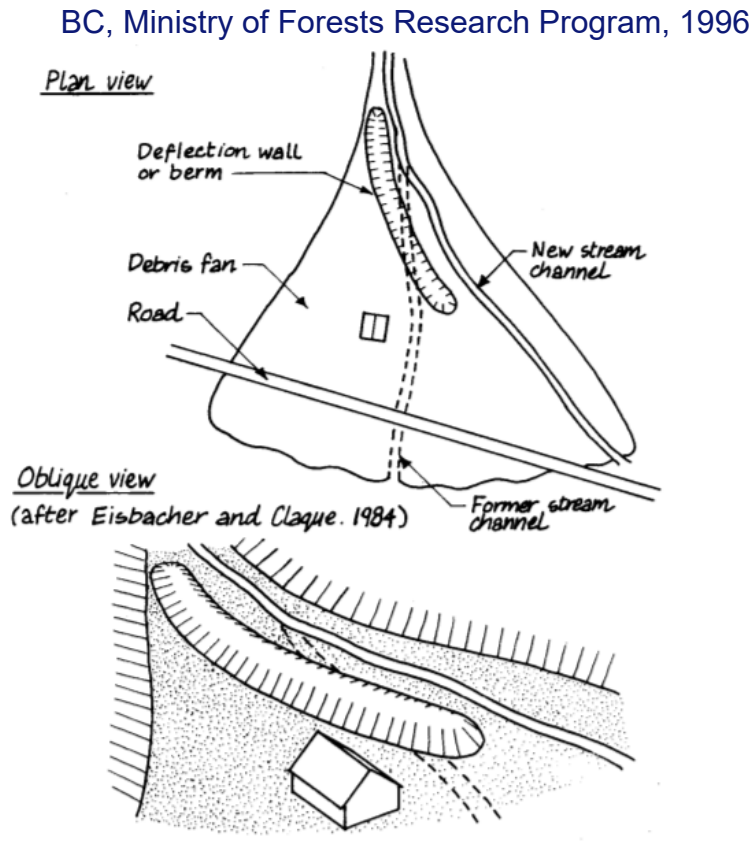
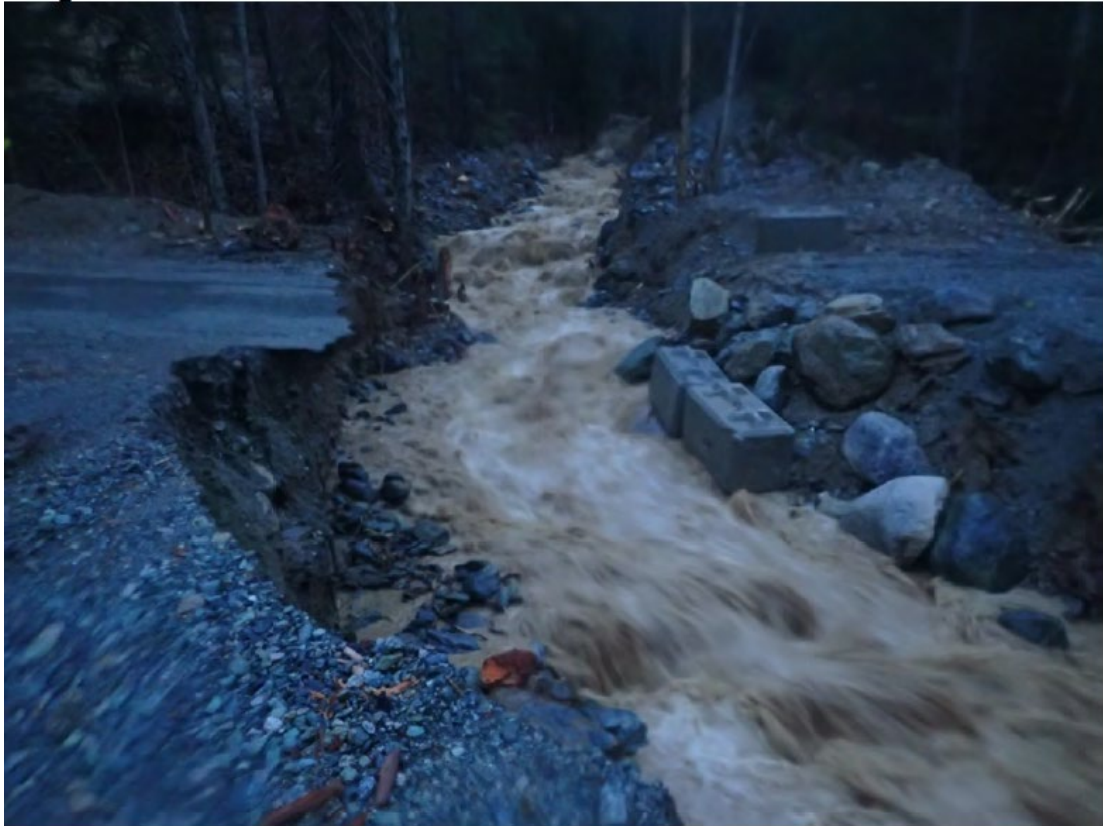
December 1, 2021 (Cordilleran, 2021)

# Potential risk-reduction system includes a deflection berm downstream of the fan apex and improvements to the Reid Road crossing.

## Deflection berm

Divert flow back into the channel with an erosion-protected earthen berm.

## Reid Road crossing

Increase capacity and resilience to debris flows.
