June 14, 2019

File: 21452

**OVERVIEW GEOHAZARD ASSESSMENT - FURRY CREEK LANDS  
FURRY CREEK, BC**

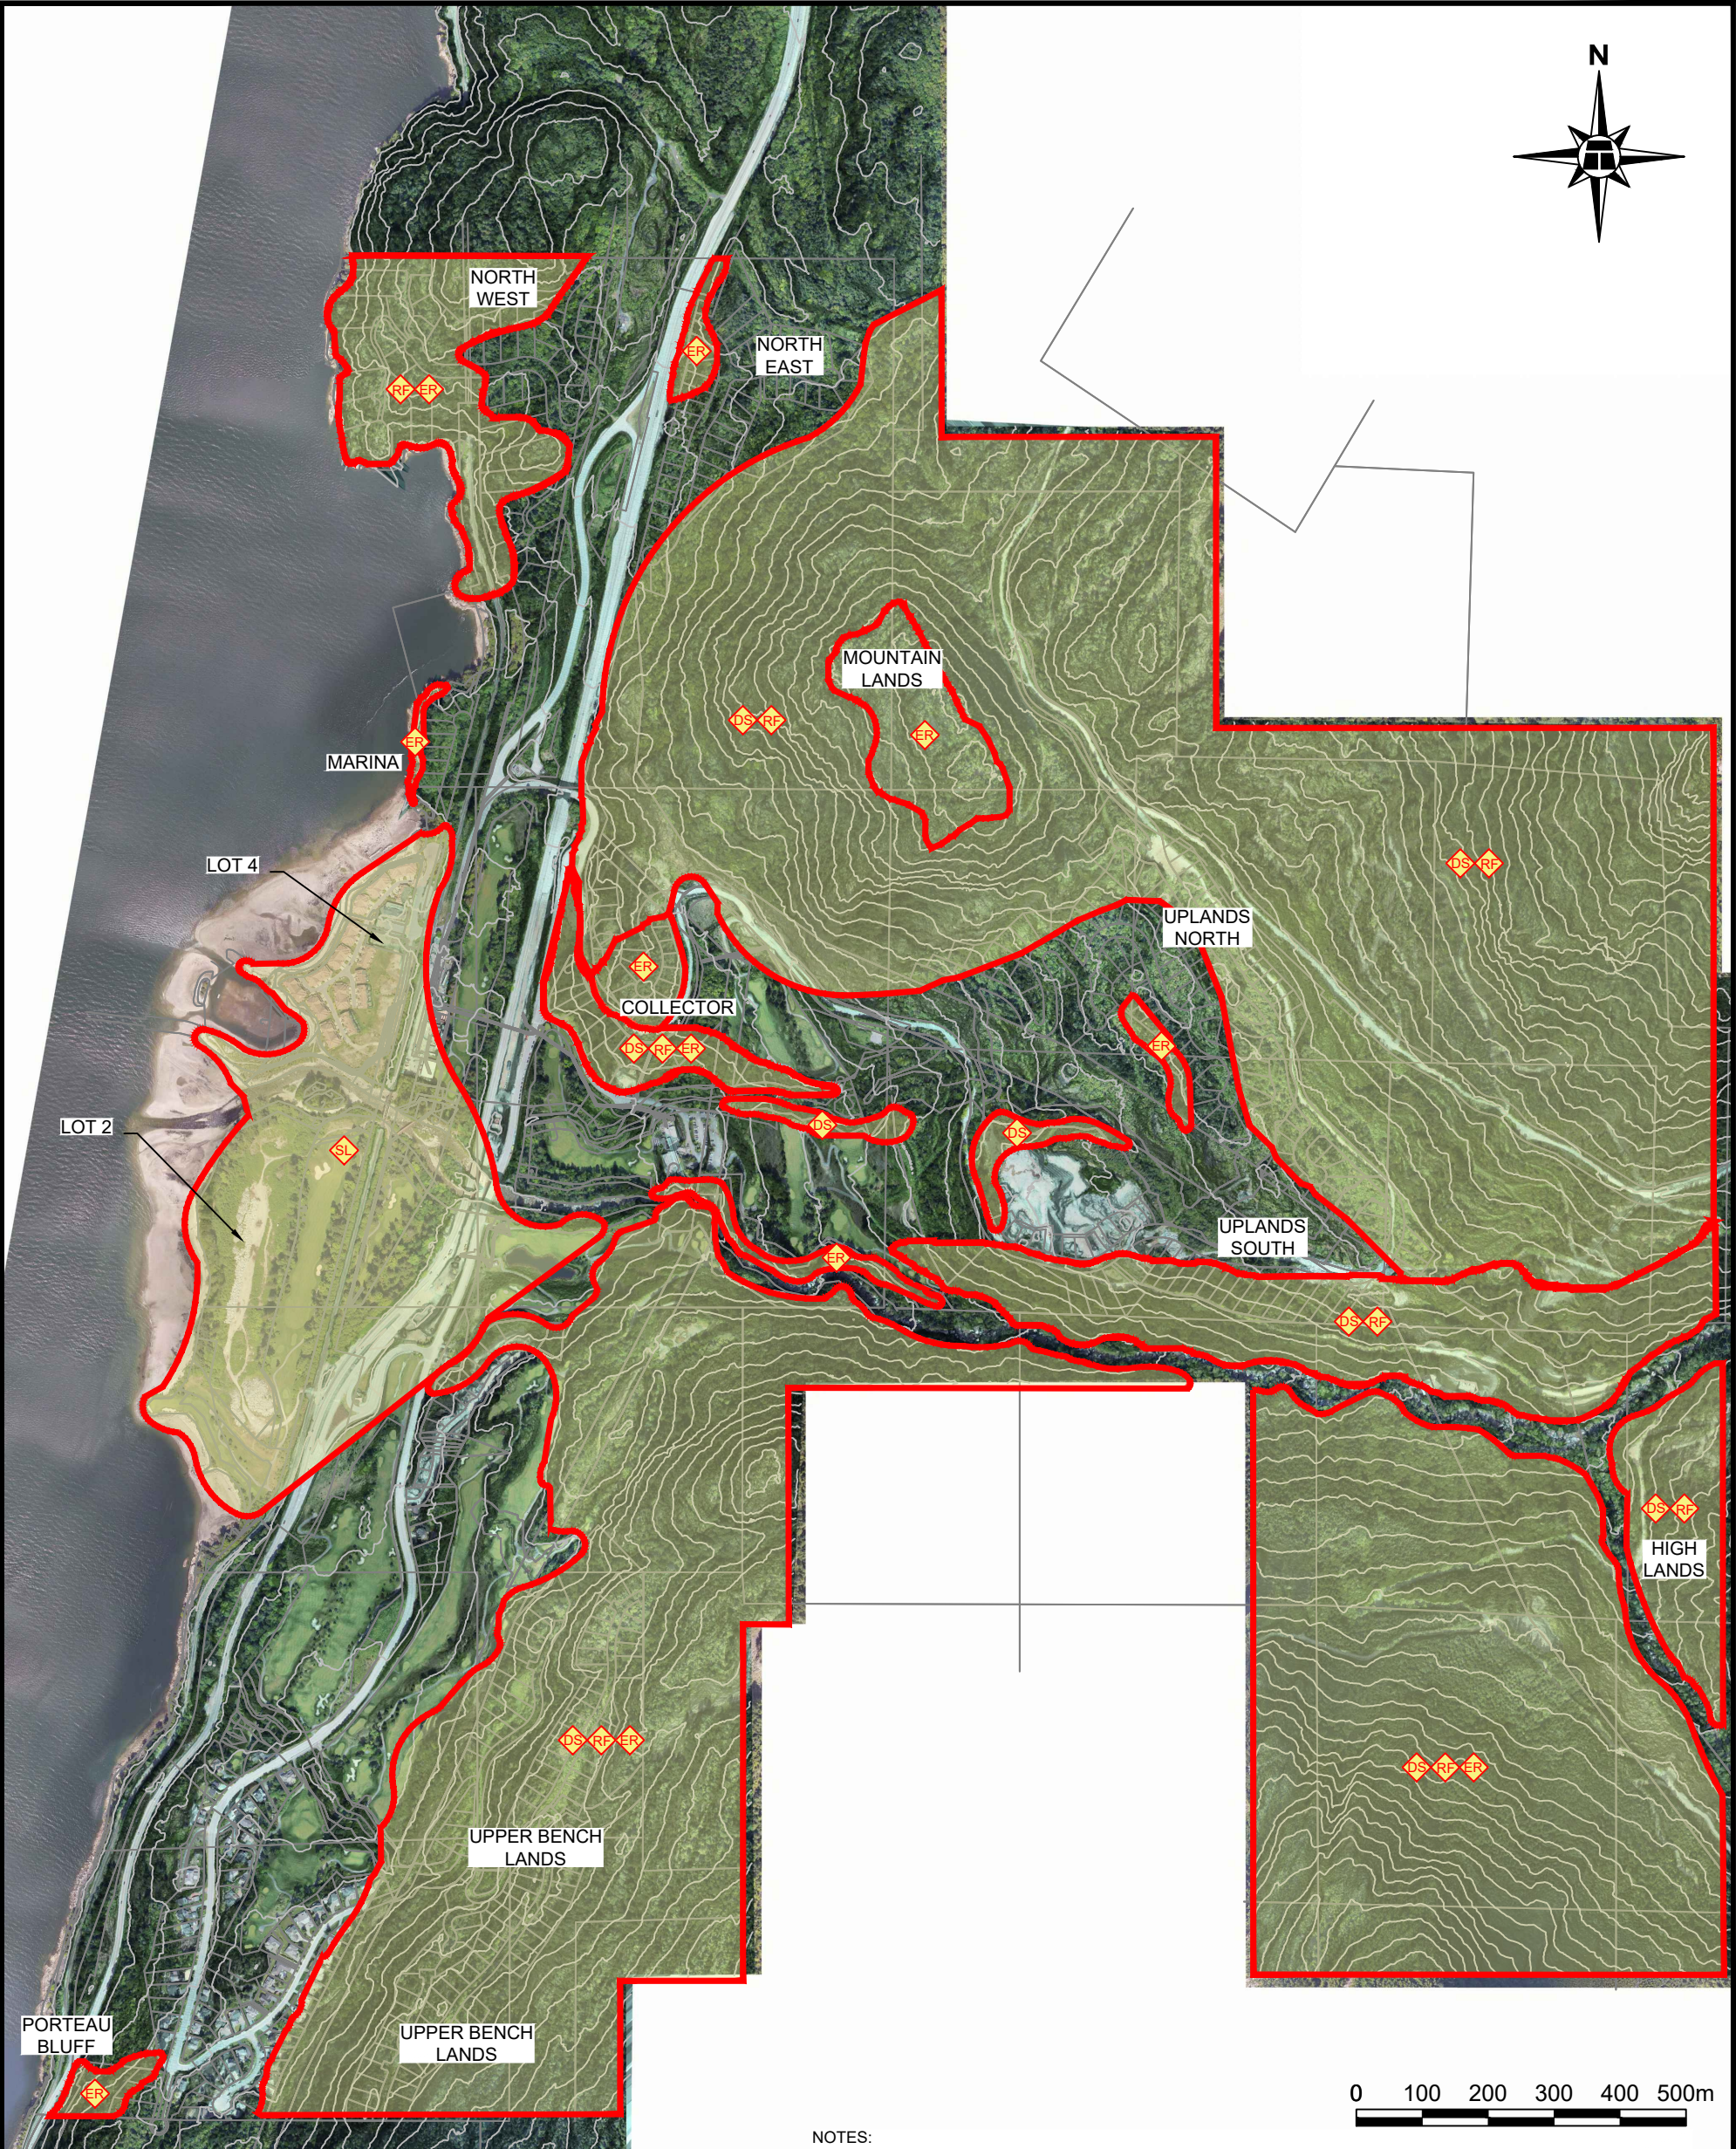
Figure 2 shows the approximate extent of potentially damaging geohazards, mapped at 1:5,000 scale from the available LiDAR imagery. Landslide hazards have been assessed based on an estimated probability of occurrence of 10% in 50 years (1:475 annual probability). Symbols within each hazard polygon denote the primary hazard types identified.

The mapped hazards on Figure 2 are conditional which means they are subject to change pending further geotechnical assessment and once the layout of the proposed roads, lots and building footprints has been finalized. Unexpected determination of hazard may affect lots now judged to be hazard free.

1. The proposed developments should, where possible, avoid the geotechnical hazard areas shown on Figure 2. However, based on the referenced geohazard acceptability criteria, we expect that many of the proposed lots within the hazard areas can be rendered feasible for development with further, site-specific geotechnical assessment to verify lot siting and recommended provisions for protective works, slope and foundation treatments, and construction practices.

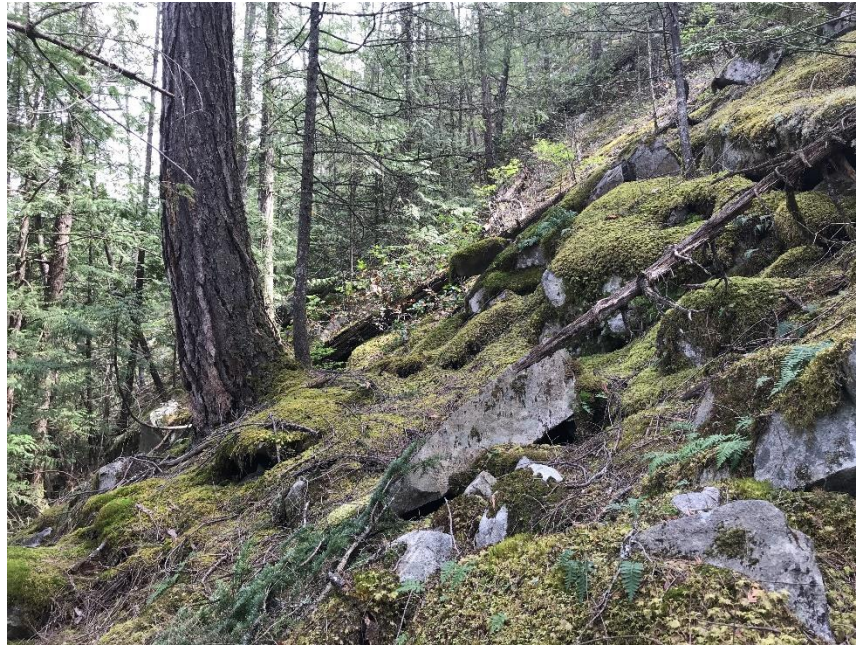
**PHOTO 1:** View of talus deposits (rock fall debris) in the Upper Benchlands area.

3. The observed rock fall hazards in the Upper Benchlands area require further, detailed geotechnical assessment. In the interim, we suggest that this area be given lower priority for development for the reasons described in Section 3.5.2.

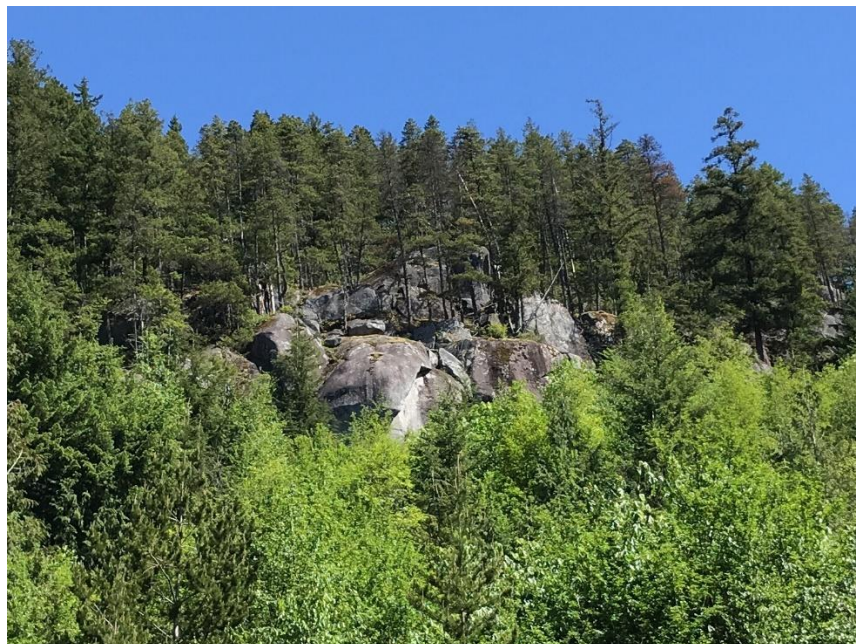
- Within the Uplands North area, where blocks of fallen rock up to 8 m in diameter were noted at scattered locations near the toe of the high mountain slopes at the eastern margin of the proposed development. These mountain slopes rise to a high alpine ridge at about the 1100 m elevation contour. The probable source area(s) and frequency of rock fall from these slopes is uncertain; however, as shown on Sketch A-1 in Appendix A, the distribution

of the observed blocks suggests that rock fall activity may be concentrated within chutes/gullies on these slopes. Avoidance of this area is judged to be the only practical mitigation strategy given the massive size of these blocks and the potential seriousness of the hazard.

**PHOTO 2:** View of rock bluffs high upslope (east) of the Uplands North area. Light-colored areas on the bluffs indicate where relatively recent rock fall has occurred.

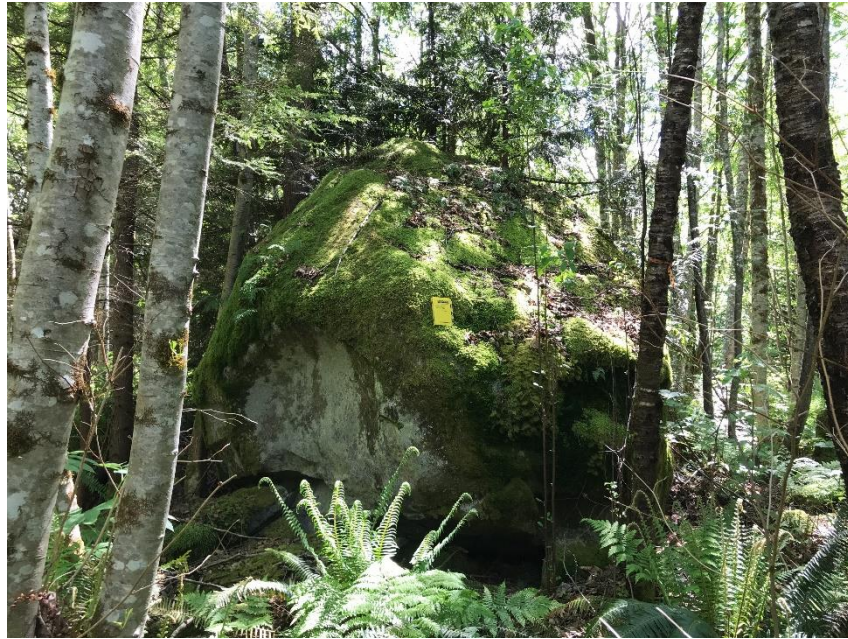
**PHOTO 3:** View of rock fall debris along the east side of Uplands North area, near the toe of the steep mountain slopes. Note the field notebook in centre of photo for scale.

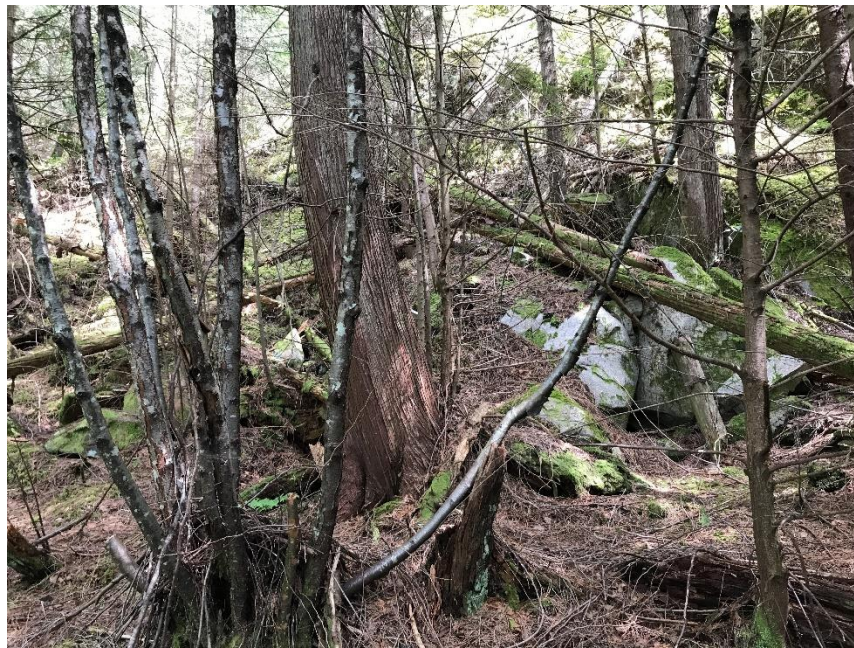
**PHOTO 4:** View of scatted rock fall debris (talus) at the north end of the Uplands North area, near the base of the Mountain lands.

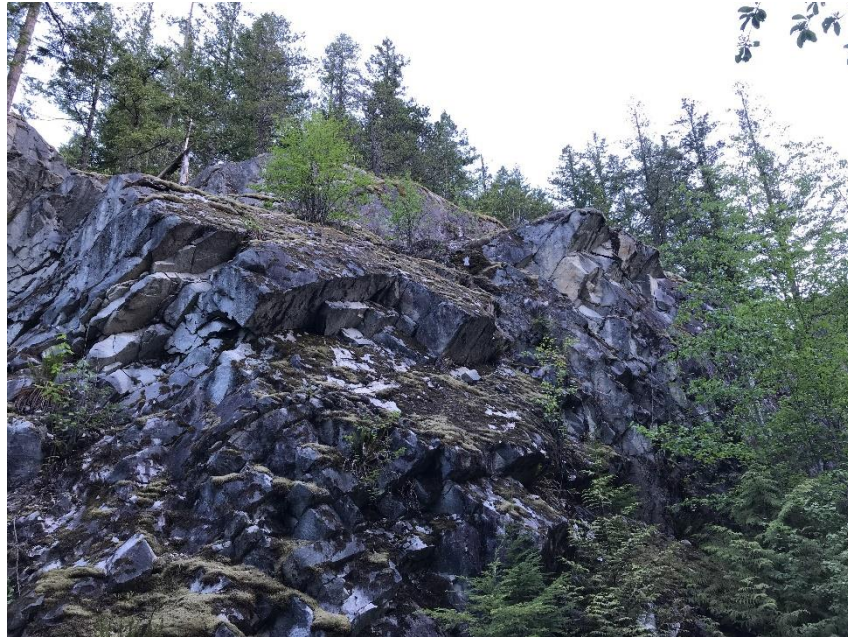
Figure 2 shows a number of areas across the subject property with possible geotechnical hazards where proposed developments are located on or adjacent to steep bedrock slopes (also see Photos 5 to 8, attached). Within these areas, further, site-specific geotechnical assessments will be required to confirm the siting of individual buildings and associated foundation design and construction requirements. Where the buildings cannot be adequately set back from the crest of these slopes, it will be necessary to construct the buildings with specially designed foundations, using carefully excavated platforms and rock anchors. These buildings will need to be very carefully sited and the building, its access and landscaping designed with input from both geotechnical and structural engineering disciplines. Protective measures may also be required at these locations to mitigate risks from rock fall.

**PHOTO 5:** View of steep rock bluffs upslope of the existing gravel road in the Collector area.

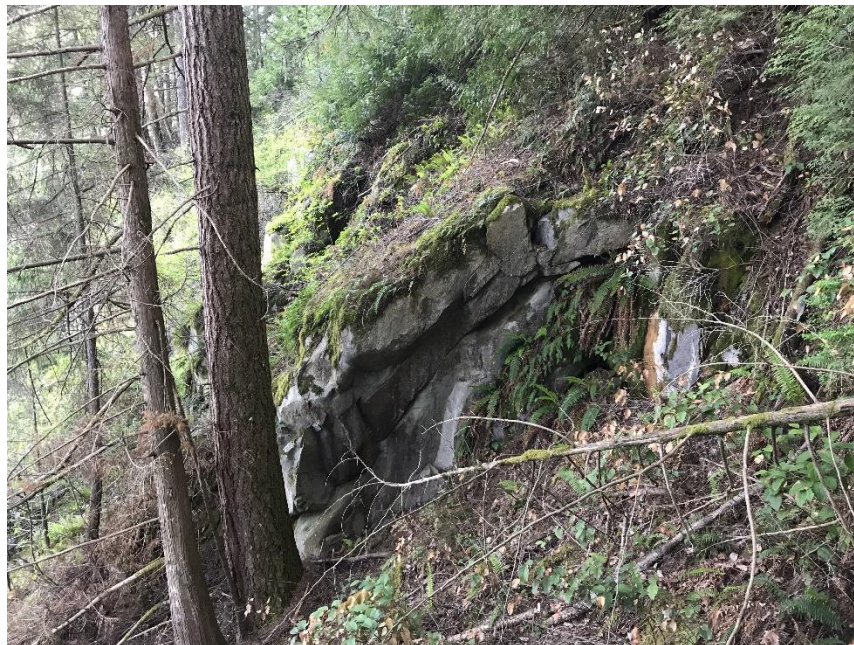
**PHOTO 6:** View of steep bedrock bluffs in the Collector area, upslope of Clubhouse Road.

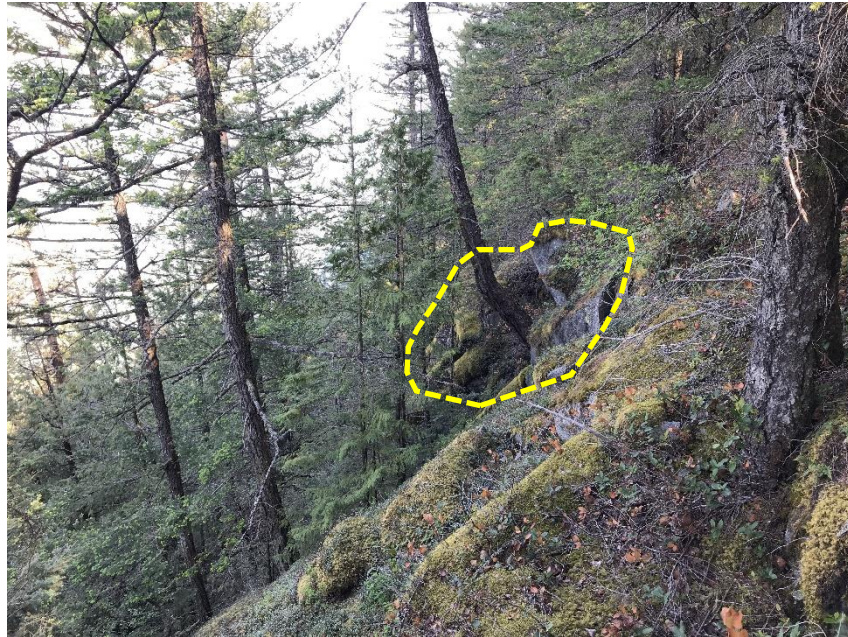
- Within the Northwest and Collector areas, where semi-detached rock masses with open (dilated) joints were observed along the margins of steep bedrock bluffs up to 50 m in height. Rock fall activity from these areas appears relatively infrequent, given the relative scarcity of debris at the base of the bluffs; however, localized detachments weighing from a few kilograms to several tonnes are certainly possible and difficult to predict. The development layouts appear to be relatively favourably sited with respect to rock fall in that the proposed buildings and roads generally follow the ridgelines; however, there may be isolated adverse occurrences requiring protective measures and/or slope treatments (i.e. scaling, shotcrete, rock bolting, trim blasting, etc.) to mitigate the risk.

**PHOTO 7:** View of steep bedrock bluffs within the Northwest area.  
Yellow polygon shows partially detached rock mass.

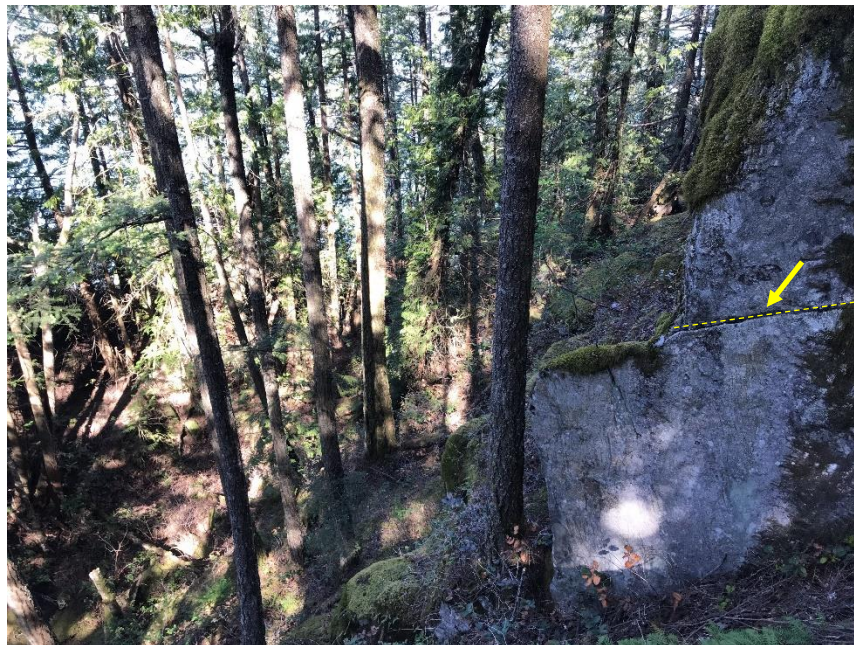
**PHOTO 8:** View of steep bedrock bluffs within the Northwest area.  
Yellow arrow indicates unfavourably oriented fracture plane dipping out of the slope.

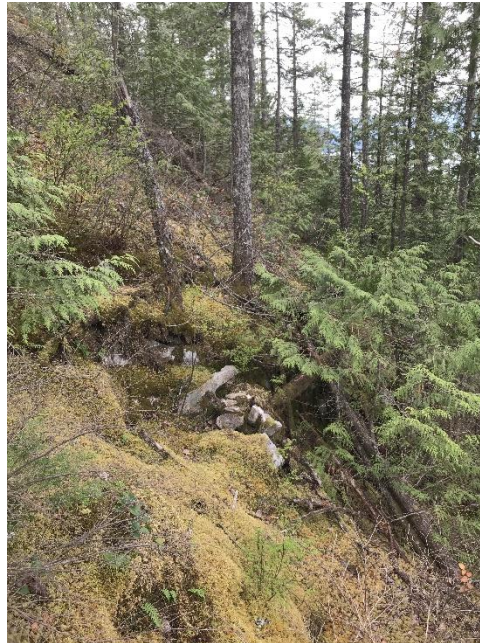
- Within the Upper Benchlands area, where the steep bedrock slopes are locally mantled by veneers of organic and mineral soil with observed seepage at the soil/rock interface.

**PHOTO 9:** View of steep slopes in the Upper Benchlands area with evidence of shallow sloughing in the thin veneer of soil overlying bedrock.

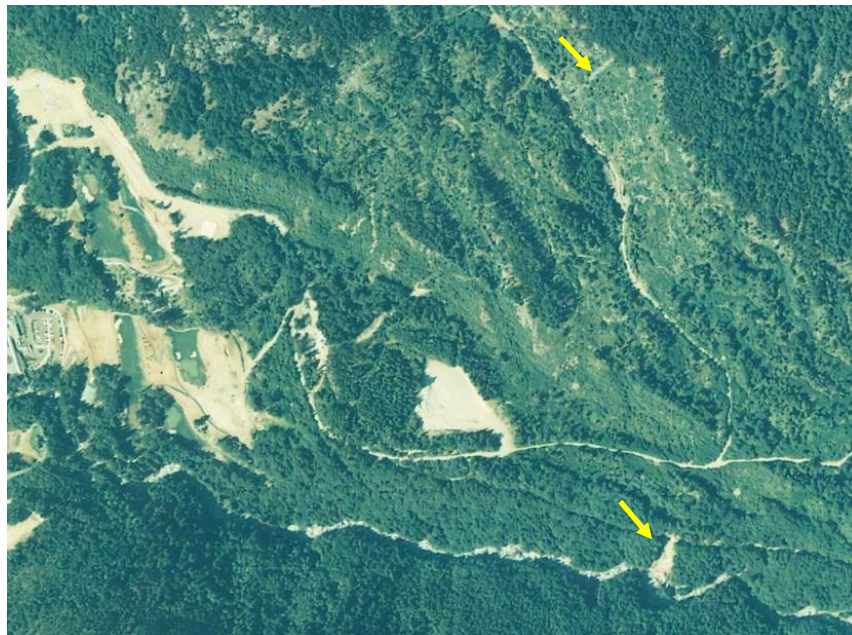
- Within the Uplands North area, where an inferred slide track was observed upslope (east) of the proposed developments on the 1994 air photos, extending to about the present location of the FSR.

**PHOTO 10:** View of inferred landslide tracks (indicated by yellow arrows) from a 1994 air photo of the Uplands area.
