# North Arm Farm Tasting Room - Geotechnical Report

The property owners at 1888 Sea to Sky Highway propose to construct an addition to an existing farm storage building. The addition is proposed as approximately 41' wide x 30', with a small vestibule and washrooms of 25ft x 15ft long attached. The added space is proposed to be used for a brewery tasting room.

PK Read Eng  
Ltd.

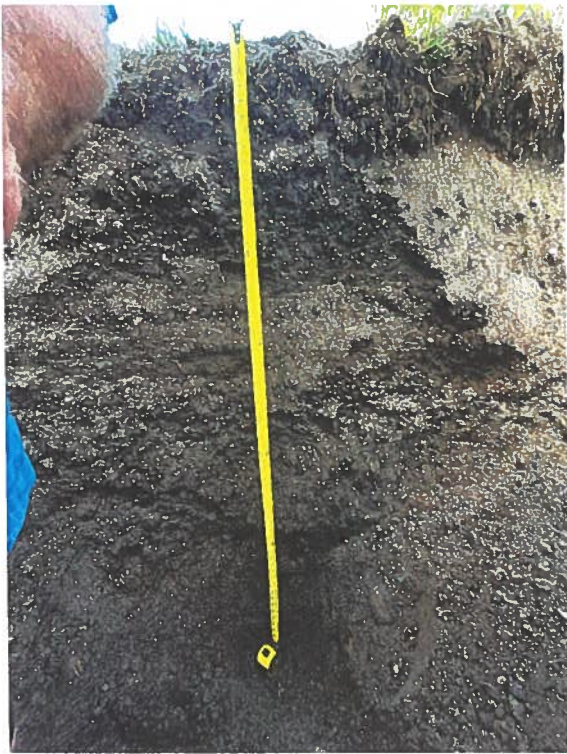
Two test pits were excavated slightly beyond the proposed building footprint Test Pit #1 was located within 20ft of the NW corner, and # 2 within 10ft of the existing NE corner foundation. Both pits showed quite similar layering and characteristics:

- '0-10" Lawn and darker topsoil mix with grass roots – c/w sands & gravels
- 10"-16" Rounded Sand & Gravel sizes <25mm GM.
- 16"-25" Coarse sand with trace gravel. Note one wall intersect some old caution tape – assumed as earlier (now abandoned) irrigation trench
- 25"-26" Thin lense fine sand & silt
- 26"-64" Channel Fill granular deposits, estimated fines as < 5%. All rounded. Pumice inclusions. No free water noted. Some moisture. Relatively firm and moderately dense. Negligible compressibility.

- '0-10" Similar mixed lawn and grass root layer
- 10"-60" Sand & Gravel bar deposit – GM. Med. Dense. Gravel sized at 2 -4"

The underlying soils to the 1.5m depth are seen as made up of channel fill sands and gravels which are relatively incompressible. The project area soils appear as characteristic of a previous gravel bar or levee of the Lillooet river.
