BRITANNIA BEACH SOUTH  
SITE DEVELOPMENT AND SERVICING  
**VOL 5 OF 5 - REFERENCES**

# Britannia Beach South

## Site Development and Servicing

### Vol 5 of 5 – References

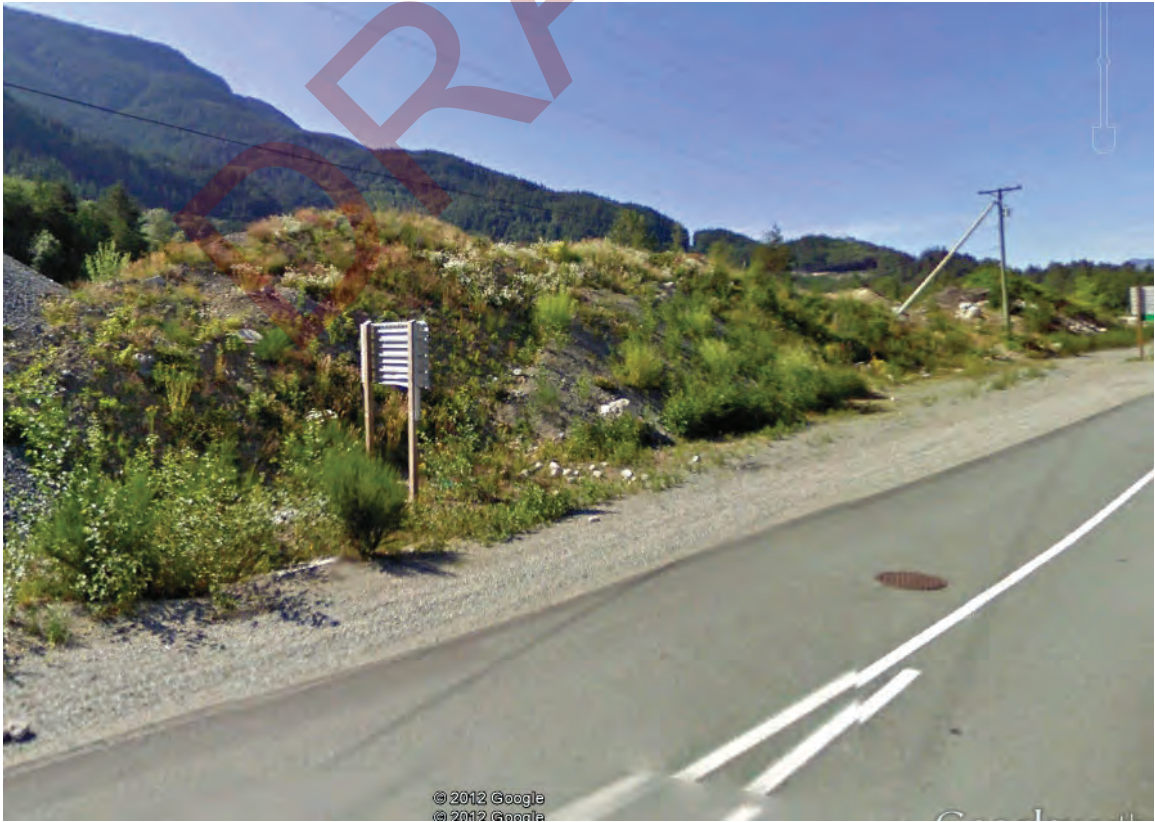
**Photo 6.**  
6!+7\$!%+'+\$7&)% "89+:.)&.: !;&\$.)%&)+7\$& '&,+;,\*.<&! #%,& '&)+%\$&,:%\$&/012Ä&=45

Stockpiling of soil and sediment is evident on the east side of Highway 99, just north of the main entrance gate (Photo 6). The origin of this material has not been confirmed. It is possible that these may be the same six stockpiles sampled by Thurber in 1997, which were suspected to have been relocated from the Britannia Mine. Copper concentrations in six grab samples collected from the piles exceeded the CSR commercial land use standard of 250 mg/kg, and lead concentrations in two samples exceeded the standard of 1,000 mg/kg. Thurber's 1997 report states that this material would eventually be removed during Site development.

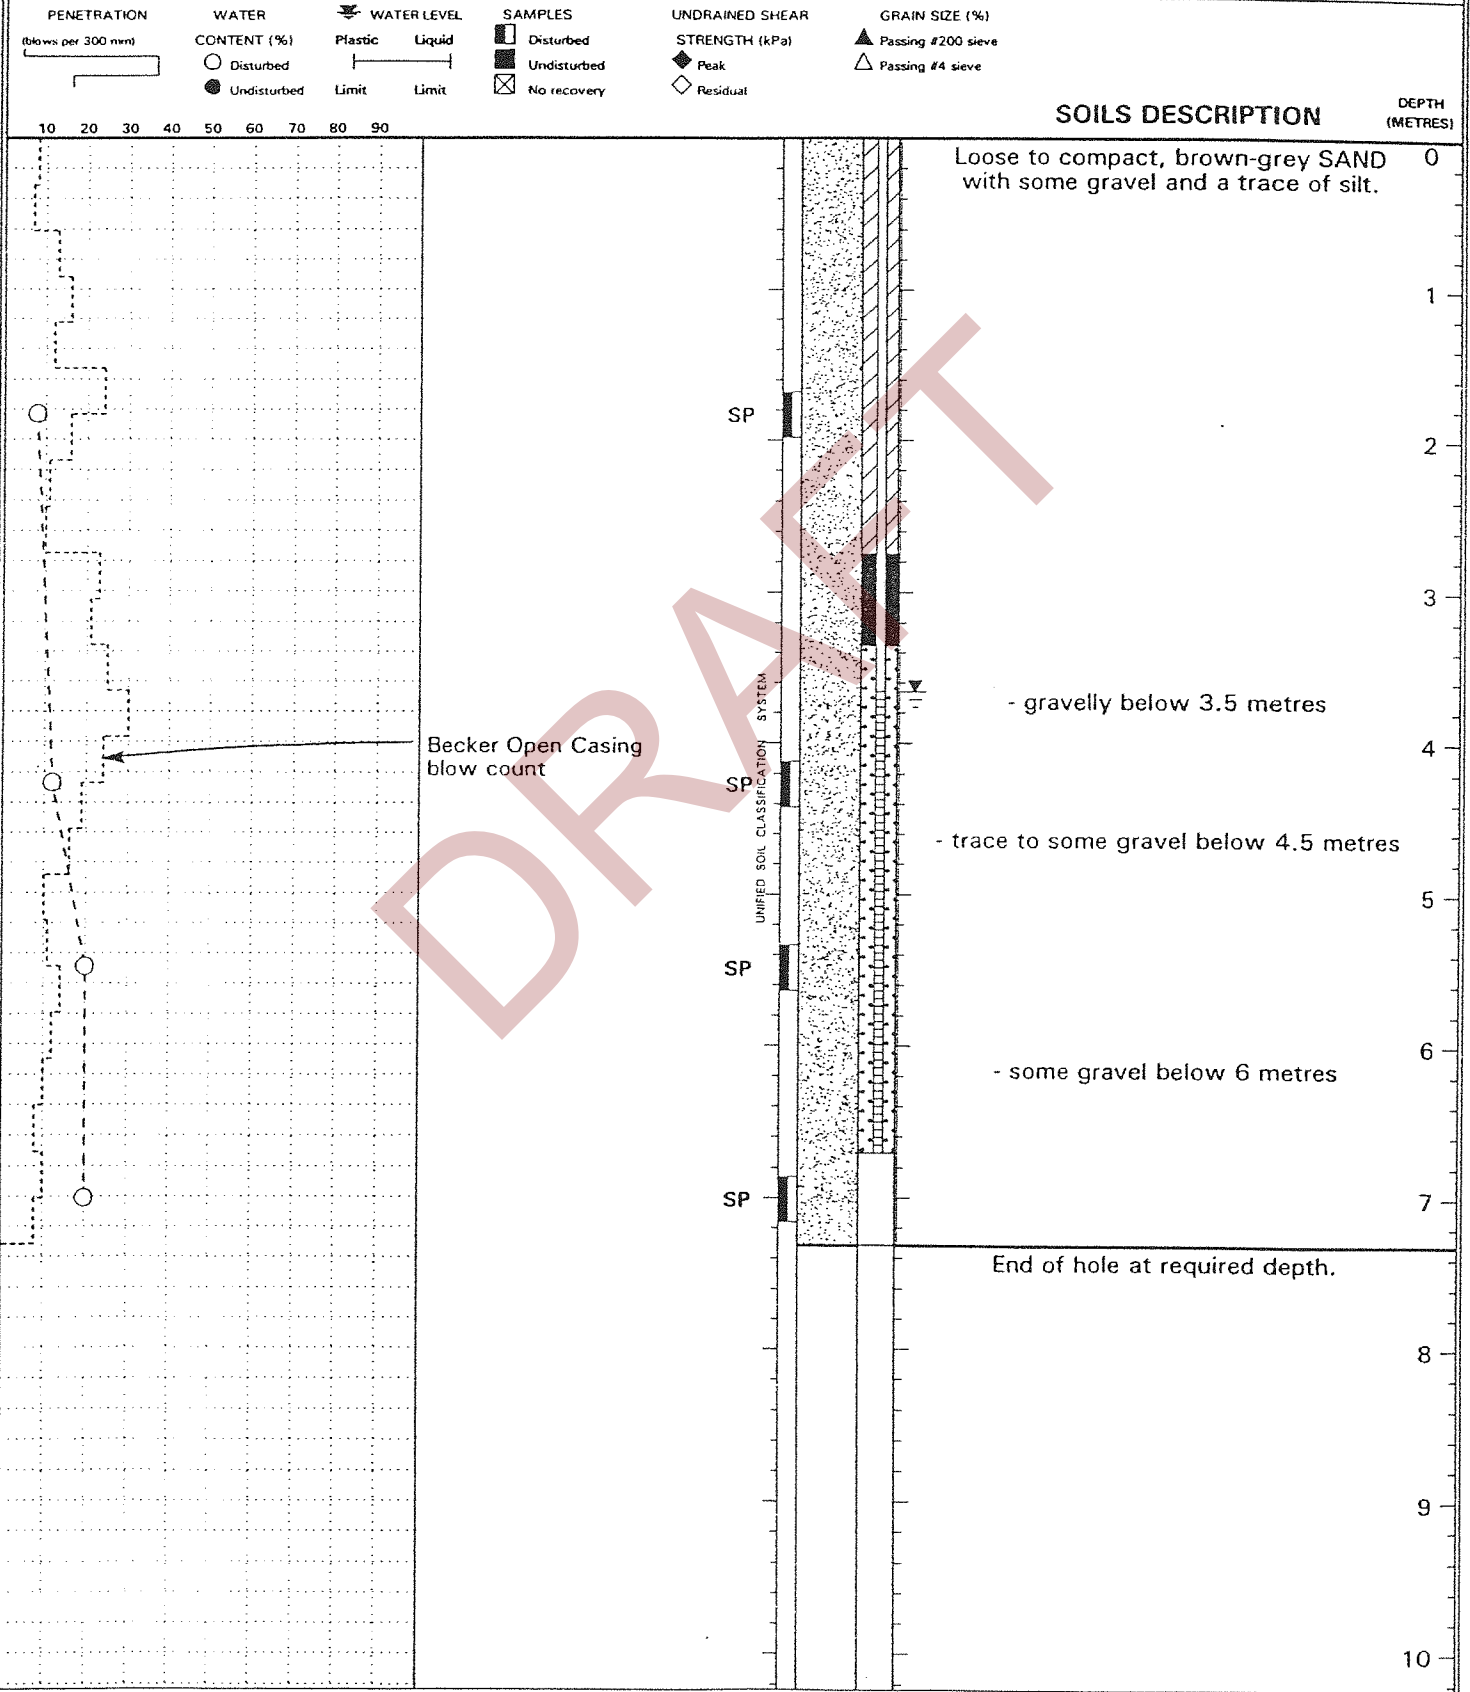
TEST HOLE NO.  
**96-3**

# LOG OF TEST HOLE

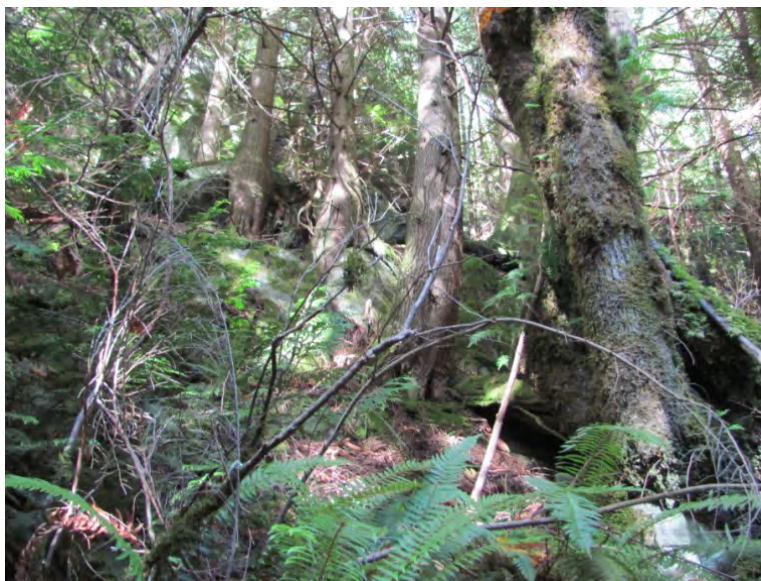
Photo 1: Typical conditions of site series 01. This photo was taken at plot 6 on October 25, 2011.

The zonal site series was observed at plots 1, 2, 4, 5, 6, 8, 9, 10, 12, 14, 15, 17, 18, 19, 21, and 24, totalling an approximate area of 80.29 ha. Variances from the typical HM conditions are described by using modifiers to address the specific conditions of each site. Eight variants were identified that take into account change in aspect, soil depth, land form and varying structural stages. Dominant and associated vegetation observed within the plots are recorded and presented in the expanded legend. A typical zonal site is presented in Photo 1.

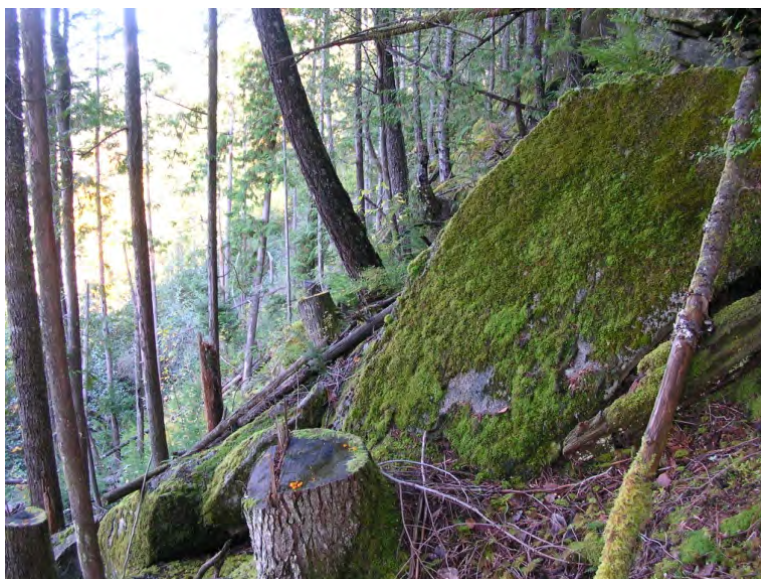
Photo 2: Typical conditions of Site Series 03. This photo was taken at Plot 7 on October 25, 2011.

Site Series 03 was observed at plots 2, 7, 11, and 20, totalling an approximate area of 26.17 ha. Variances from the typical DS conditions are described by using modifiers to address the specific conditions of each site. Three variants were identified that take into account change in aspect, soil depth, and varying structural stages. Dominant and associated vegetation observed within the plots are recorded and presented in the expanded legend. Photo documentation of conditions typical of site series 03 is presented in Photo 2.

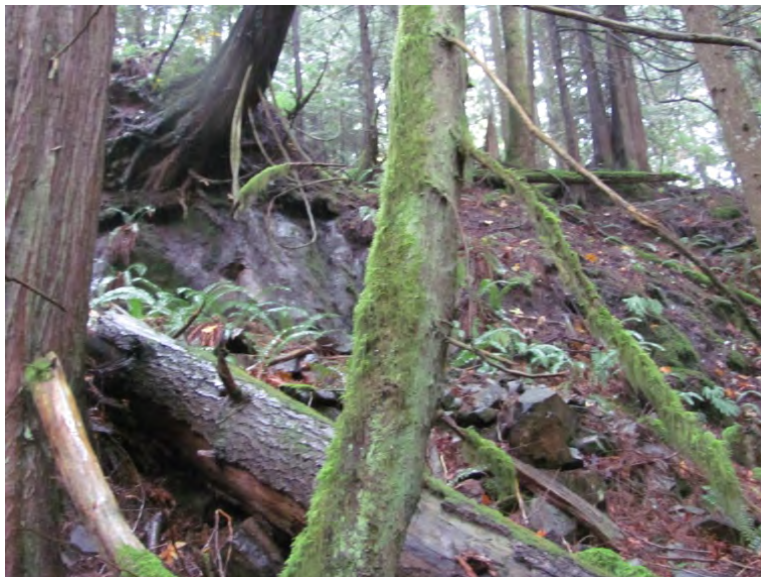
Photo 3: Typical conditions of Site Series 05. Photo taken at Plot 1 on October 21, 2011.

Site Series 05 was identified at plots 1, 3, 14, 8, 9, 17, 21, 23 and at an unverified polygon, totalling an approximate area of 27.27 ha. Variances from the typical RS conditions are described by using modifiers to address the specific conditions of each site. Six variants were identified that take into account change in aspect, soil depth, and varying structural stages. Dominant and associated vegetation observed within the plots are recorded and presented in the expanded legend. Typical site series 05 conditions are presented in Photo 3.

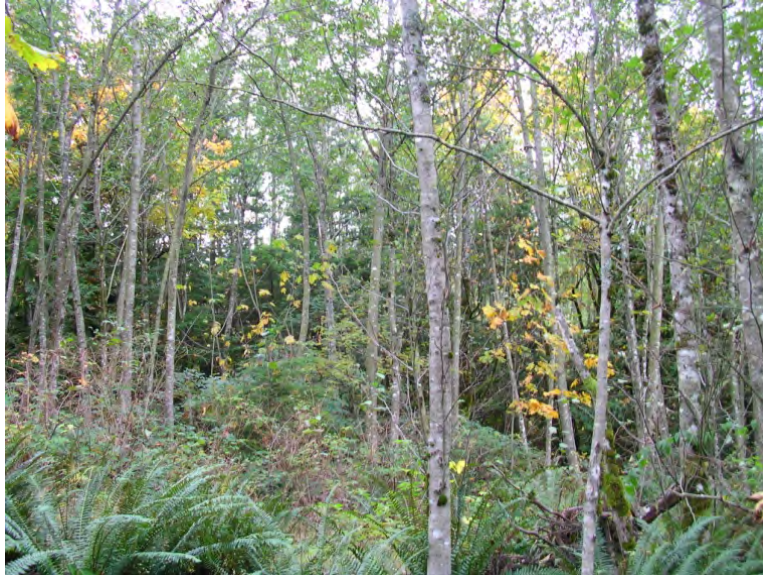
Photo 4: Typical conditions of Site Series 07. Photo taken at Plot 24 on November 1, 2011.

Site Series 07 was identified at plots 16, 22, 24 and at two unverified polygons, totalling an approximate area of 38.79. Variances from the typical RF conditions are described by using modifiers to address the specific conditions of each site. Eight variants were identified that take into account change in aspect, soil depth, and varying structural stages. Dominant and associated vegetation observed within the plots are recorded and presented in the expanded legend. Typical conditions of site series 07 are presented in Photo 4.

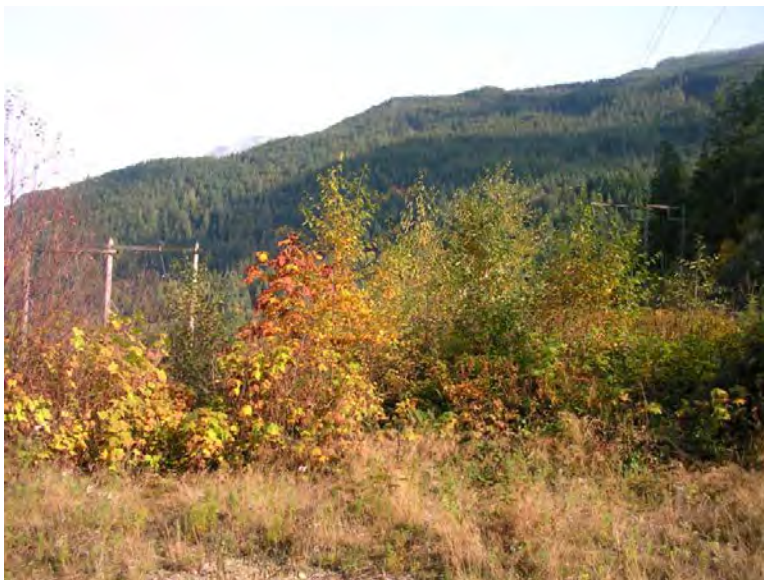
Photo 5: Typical vegetation found within the CF zone on the subject site. October 27, 2011

The TEM code “cultivated field” was the best disturbed site descriptor for the land located under powerlines on the subject property. Approximately 21.44 ha of land exist in this vegetation state. Vegetation exists in a maintained state of structural stage 3b. Species observed include salmonberry, thimbleberry, trailing blackberry, red alder, hardharck, bigleaf maple, western hemlock, western redcedar, willow, pacific ninebark, sword fern and bracken fern (Photo 5).

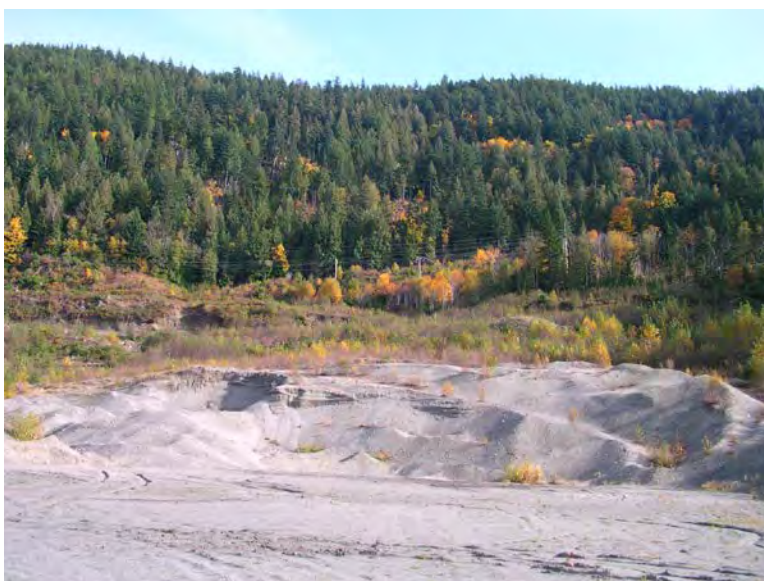
Photo 6: Typical conditions of the ES zone on the subject site. November 1, 2011

The TEM code “exposed soil” was the best disturbed site descriptor for the land that was historically mined of gravel. Approximately 30.08 ha of land exist in this state. Some shrub vegetation growth is observed on the periphery of the site, although the majority is bare gravel with minimal growth (Photo 6).

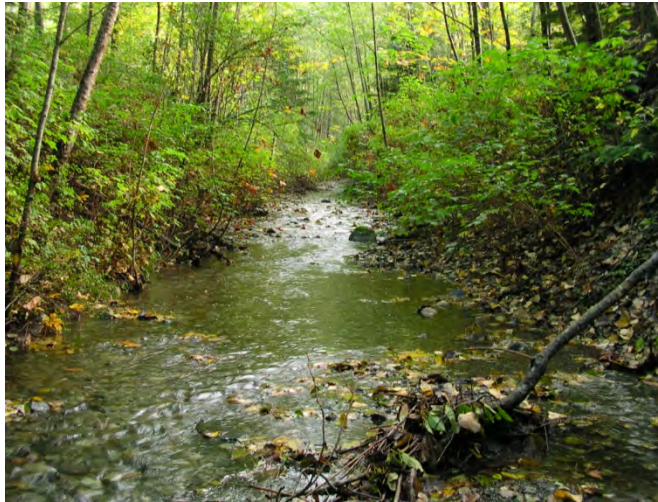
Photo 9: Reach 1 view upstream from the reach midpoint. October 20, 2011.

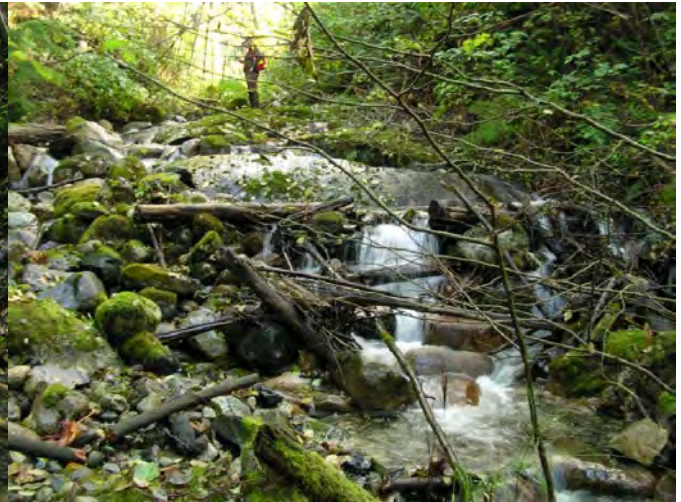
Photo 10: Reach 2 of Thistle Creek supports a steeper gradient and greater instream complexity than reach 1 characteristics. October 20, 2011.

Reach 2 is approximately 353 m in length and extends from the access road bridge to the waterfalls at the upstream reach break (Map 3). This reach is more complex than reach 1 supporting some cascades, pools, and woody debris although still appears to be an altered stream (Photo 10). This stretch of creek is steeper with an average stream gradient of 5.7 %, average channel width of 6.0 m and average wetted width of 2.7 m measured on October 20, 2011. Flow stage at that time was low with an average water depth of 0.2 m. The average bank-full depth was 0.82 m. Temperature was measured at 10°C, and the water turbidity was noted as clear. Bed material was dominated by cobble with boulders being subdominant. D95 in this reach was 75 cm, with a D of 40 cm. Abundant cover existed in the form of LWD, boulders and overstream vegetation. The stream banks are sloped consisting of a substrate dominated by fines and gravels. Riparian vegetation was a young deciduous forest with a crown closure of 21-40%. Instream woody debris and stream complexity increased towards the waterfalls, and the forest changed to a coniferous dominated stand.

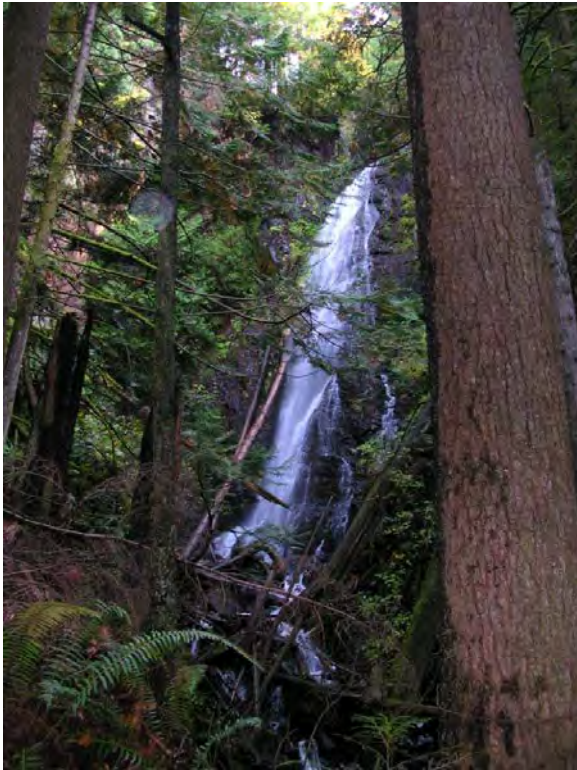
Photo 11: Thistle Creek waterfalls mark the division between reach 2 and 3. October 20, 2011

Reach 3 extends approximately 689 m from the waterfalls to the property boundary (Map 3; Photo 11 and 12). The reach is considered non fish bearing as the waterfalls are impassable to fish and Thistle Creek is not fed by an upstream lake. Six minnow traps were set in Reach 3 overnight October 26, 2011. No fish were caught after a soak time of 24 hours. Upstream of the falls, this reach has an average stream gradient of 5.7 %, average channel width of 6.0 m and average wetted width of 2.7 m. Thistle Creek flows into an area of alluvial fan as the creek flows off of the steep upper slopes and before reaching the waterfalls (Thurber, 2011). Flow stage was low on November 4, 2011, with an average water depth of 0.2 m, and an average bank-full depth of 0.82 m. Temperature was measured at 4°C, and the water turbidity was noted as clear. Bed material was dominated by cobble with boulders being subdominant. D95 in this reach was 75 cm, with a D of 40 cm. Abundant cover existed in the form of LWD, boulders and over-stream vegetation. The stream banks are sloped consisting of a substrate dominated by fines and gravels. Riparian vegetation was a young deciduous forest with a crown closure of 21-40%.

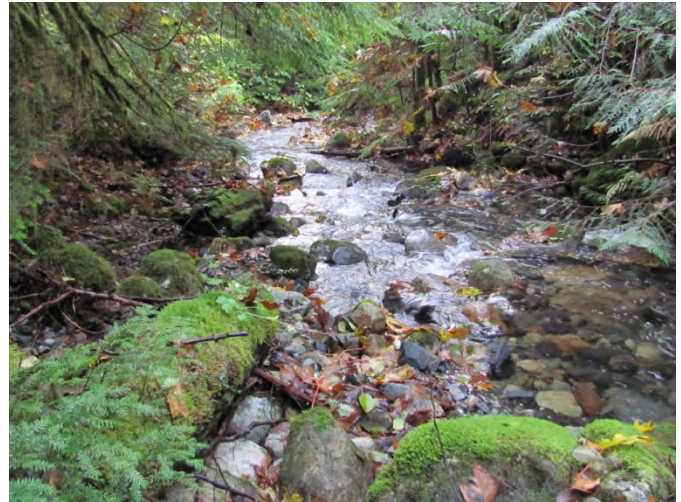
Photo 12: View of Thistle Creek reach 3 facing downstream. October 26, 2011

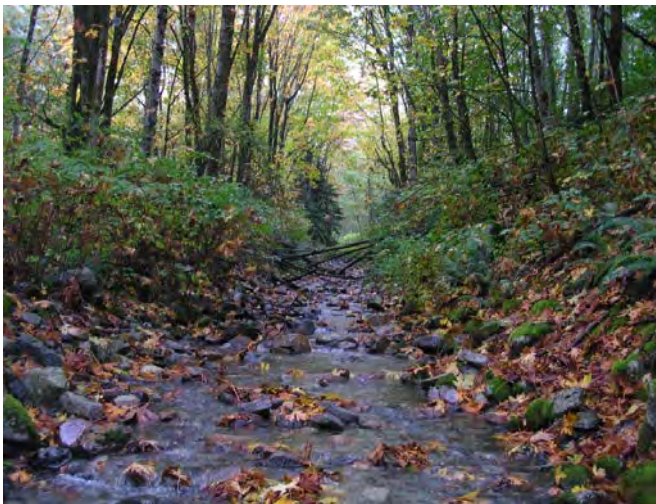
Photo 13: View upstream within reach 1 of Daisy Creek. October 26, 2011.

Reach 1 extends approximately 500 m from Howe Sound (Map 3). The reach has similar morphology to that of reach 1 of Thistle Creek although it supports a slightly higher level of complexity with a slightly larger range in substrate size, more woody debris in the channel and a slightly steeper gradient of 3.5% (Photo 13). The average channel width was 5.5 m and the average wetted width was 3.4 m measured during the stream assessment of October 26, 2011. Flow stage was low during the stream assessment with an average water depth of 0.18 m, and an average bank-full depth of 0.66 m. Water turbidity was noted as clear. Bed material was dominated by gravel with cobbles being subdominant. D95 in this reach was 34 cm, with a D of 43 cm. Trace amounts of cover were present as LWD, and boulders. The stream banks are vertical and consisting of fines, gravel and cobbles. Riparian vegetation was a young deciduous forest with a crown closure of 21-40%.

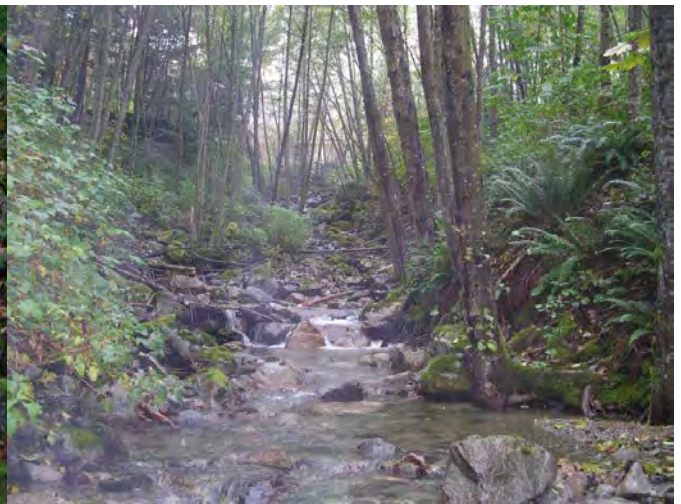
Photo 14: View upstream from the start of reach 2, Daisy Creek. October 26, 2011.

Reach 2 is approximately 256 m in length extending from reach 1 to the bottom of the waterfalls located upstream of Highway 99, and is characterized as cascade-pool morphology, containing more functional woody debris than reach 1 (Photo 14; Map 3). This stretch of creek is steeper with an average stream gradient of 21 %, average channel width of 8.4 m and average wetted width of 3.7 m. Flow stage is low with an average water depth of 0.2 m, and an average bank-full depth of 0.7 m. Water turbidity was noted as clear, and bed material was dominated by boulder with cobble being subdominant. D95 in this reach was 58 cm, with a D of 80 cm. Instream cover exists in the form of LWD and boulders. The stream banks are vertical consisting of a substrate dominated by boulders. Riparian vegetation is a young deciduous forest with a crown closure of 21-40%.

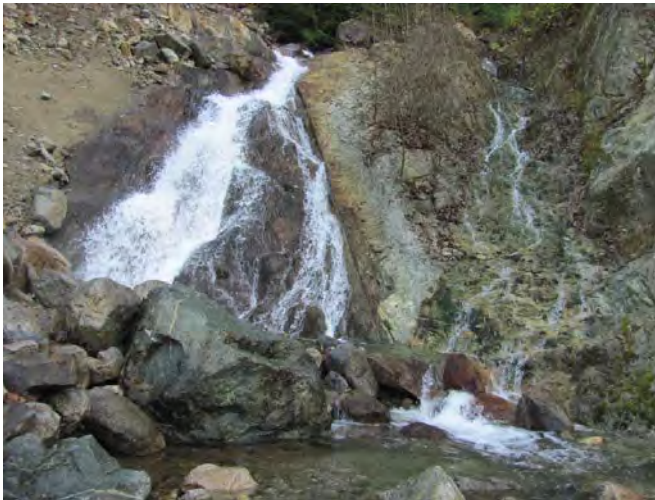
Photo 15: Daisy Creek waterfalls. The falls are a barrier to fish passage and mark the division between reach 2 and 3. November 4, 2011.

The reach is steep with an average stream gradient of 23 %, average channel width of 7.7 m and an average wetted width of 4.8 m. Flow stage is low, temperature was measured at 5.5°C, and the water turbidity was noted as clear. Bed material was dominated by boulders with cobbles being subdominant. D95 in this reach was 55 cm, with a D of 65 cm. Medium amounts of cover existed in the form of LWD and over-stream vegetation, with trace amounts of undercut banks. The stream banks are sloped consisting of a substrate dominated by cobbles and boulders. Riparian vegetation was a young mixed forest with a crown closure of 1-20%.

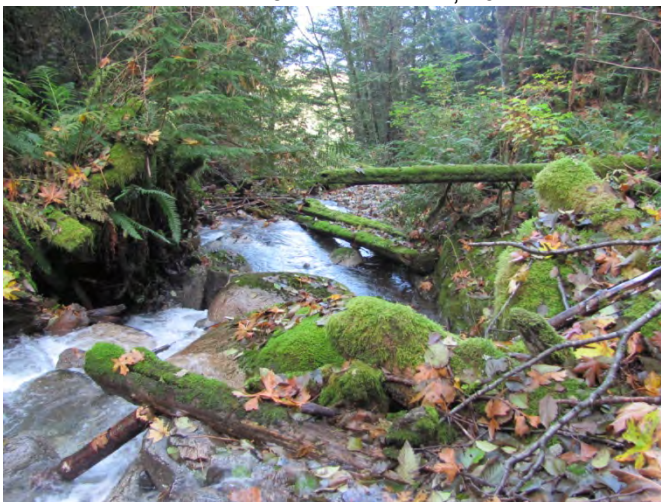
Photo 17: View downstream in reach 3, Daisy Creek, November 4, 2011.

The reach is cascade-pool morphology with significant amounts of woody debris and coarse debris accumulation (Photo 17). The channel upstream of the waterfalls is relatively mobile and prone to debris flows. A debris basin was built at the toe of the waterfalls during the upgrade of Highway 99. Thurber Engineering assessed the creek in 1997 to have a moderately high

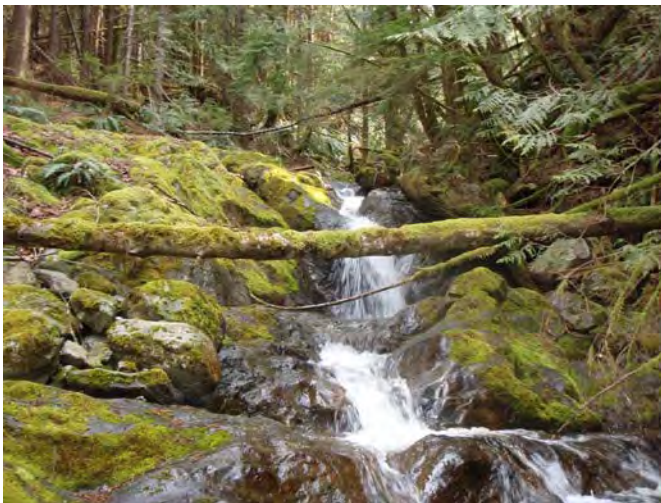
Photo 18: View of the bedrock waterfalls marking the break between reach 3 and 4 of Daisy Creek. Photo taken facing upstream. April 24, 2008.

Reach 4 extends from the bedrock falls (Photo 18) approximately 375 m upstream. The downstream bedrock falls is comprised of multiple steps with an overall gradient of 30% over a length of 30 m. This bedrock chute constitutes a barrier to fish passage. Stream morphology of the reach is step pool with frequently exposed bedrock and log jams forming drops up to 2.5 m in height, all of which constitute barriers to fish passage (Photo 19). Additionally a slot canyon of approximately 50 m in length exists about 100 m into the reach and presents a substantial barrier to fish passage. Average channel width was 10.2 m with an average wetted width of 3.4 m on April 24, 2008. Gradient averaged 18.5%. Stream substrate is dominated by boulders with cobbles and gravel sub-dominant. Abundant cover is provided by large woody debris including log jams, boulders, deep pools, and moderate amounts of small woody debris and over-stream vegetation. One tailed frog tadpole was captured in this reach incidental to the electrofishing effort; however, no fish were captured by either electrofishing or G-trapping (Cascade, 2008). The fish survey was not conducted beyond the end of this reach as no fish were detected in this reach, nor within reach 3 during the April 2008 sampling period.

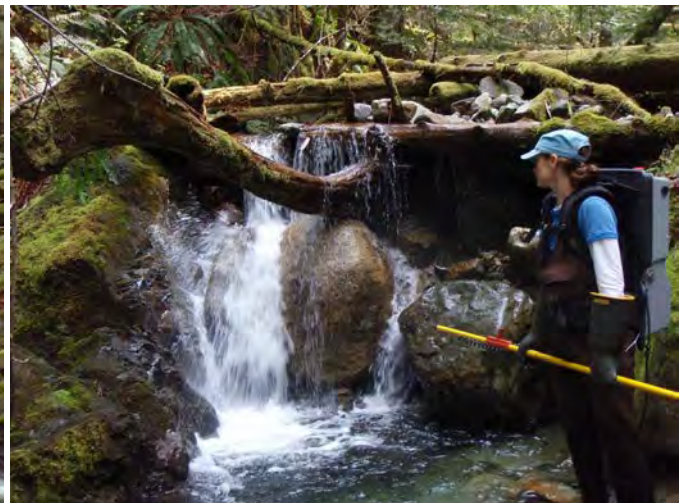
Photo 19: Reach 4 has numerous log/boulder jams greater than 2 m in height. April 24, 2008.

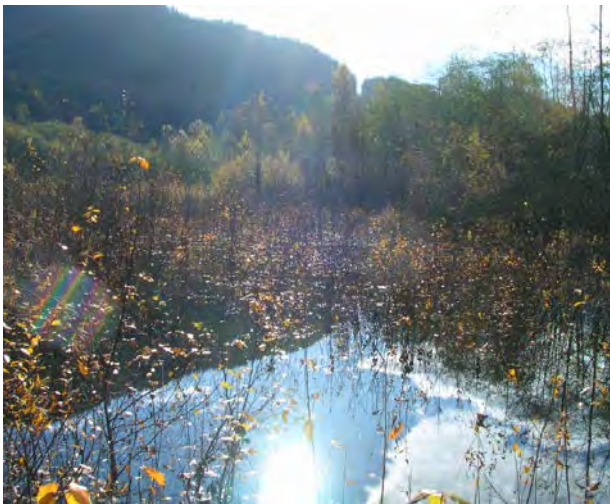
Photo 20: View facing south of the wetland pool system; 1<sup>st</sup> Tributary to Thistle Creek, Reach 1. November 15, 2011

This tributary (aka Gravel Creek) drains into reach 1 of Thistle Creek, immediately upstream of Highway 99. The tributary drains the lands to the north of Thistle Creek flows through the gravel pit. This tributary can be divided into three reaches based on the level of disturbance and differences in channel morphology. Reach 1 consists of a series of excavated pools connected by ditches to the confluence with Thistle Creek (Photo 20). This reach is described in more detail in the wetland section below (Section 2.3.4). The second reach consists of a channelized stream (i.e. ditch) that directs water from the hillside across the low gradient historic gravel pit into the ponds (Photo 21). Riparian vegetation along this reach is sparse and where vegetation exists, it is limited to pioneering species. The third reach is steep and extends up the hillside to the headwaters of the drainage. Reach 3 flows perpendicular and under two roads that follow the contour lines. As no significant roadside ditching was observed, the alignment of reach 3 is considered to be relatively undisturbed. As this section of drainage 1 flows through the hydro right-of-way, and across two roads, the riparian vegetation is generally low level shrubs consistent with those land uses (Photo 22). Further up the slope riparian vegetation changes to coniferous forest at the drainage headwaters. Fish presence in reach 1 was confirmed during this assessment (See section 2.3.4), and as no barriers to fish passage exist between reach 1 and 2, reach 2 is also considered fish bearing. Due to the steep gradients observed in reach 3, this reach is not considered fish habitat.

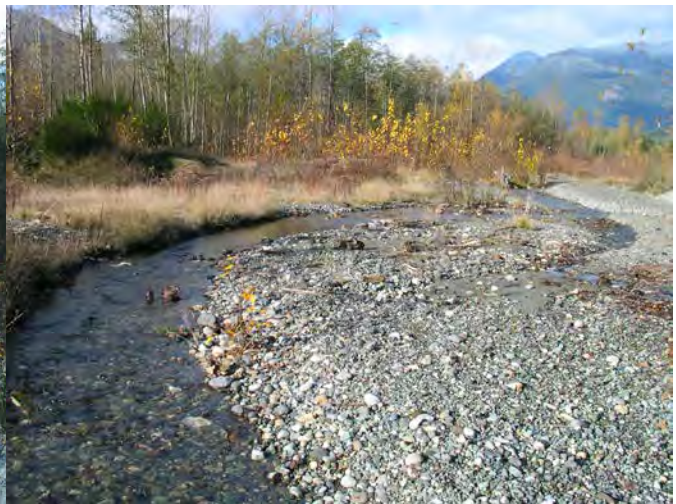
Photo 21: View facing downstream of the ditch flowing into the wetland pool system, 1<sup>st</sup> tributary to Thistle Creek, Reach 2. November 15, 2011

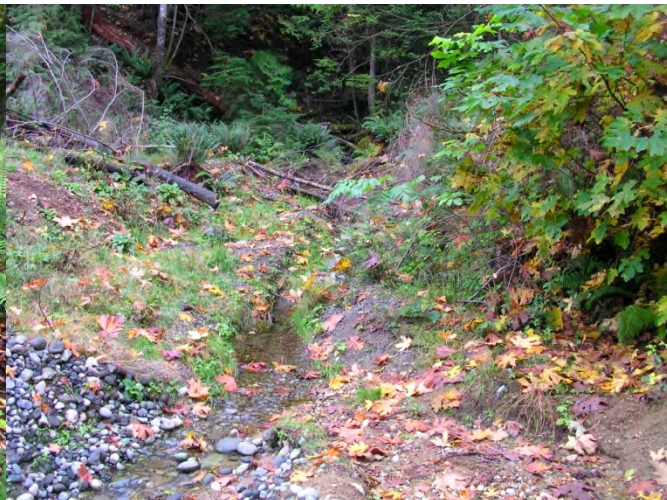
Photo 24: View upstream of drainage 3. Photo taken approximately 100 m upstream of the railroad crossing. November 1, 2011.

This tributary (aka Minaty Bay Creek) flows approximately parallel to Daisy Creek and flows into Minaty Bay (Map 3). The drainage is small with an approximate wetted width of 1 m, and flows from a culvert that drains lands upslope of Highway 99 (Photo 24). Stream substrate is gravel with a mix of young deciduous and coniferous riparian vegetation. Although stream gradient is not great enough to preclude fish presence, the small size of the drainage does not present quality fish habitat. For this reason, this drainage is not likely fish habitat, although an assessment for fish presence is recommended.

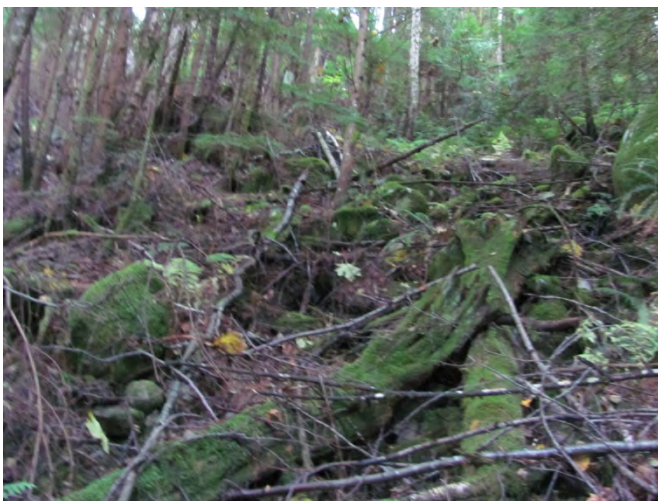
Photo 25: View upstream in drainage 4. Photo taken approximately 260 m upstream from the confluence with Daisy Creek. October 25, 2011.

This tributary drains into Daisy Creek in Reach 4. The average channel width is 4.2 m with a wetted width of 3.0 measured on October 25, 2011. The drainage is very steep with an average gradient of 48 %. Dominant substrate is gravel with boulders being subdominant. Riparian vegetation is a young mixed forest (Photo 25). Due to the steep gradient of the stream, this drainage is not considered fish habitat.

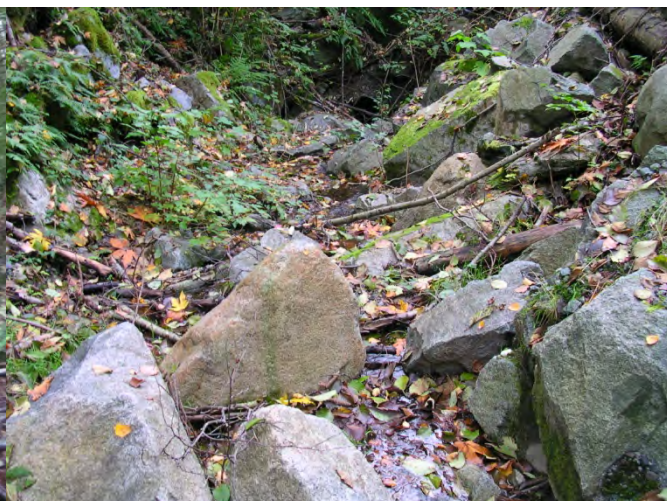
Photo 26: View of drainage 5 just upstream of the highway crossing culvert. Photo taken facing downstream.

This drainage is very small and becomes subsurface approximately 50 m upstream of the culvert under Highway 99. The channel width was 2.5 m, wetted width was 1 m, and residual pool depth was 0.05 m measured on November 1, 2011. The stream gradient was 15 % and supported gravel substrate. Riparian vegetation is young deciduous forest. Based on the shallow depth of the drainage and the subsurface nature of the creek, the drainage is not considered fish habitat.

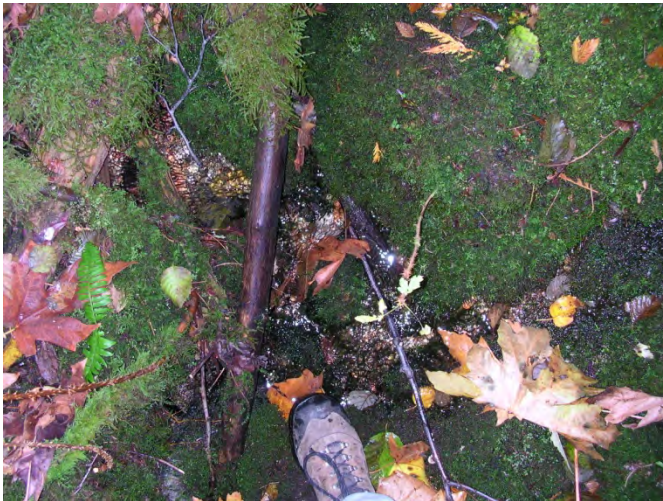
Photo 27: Drainage 6 is small and partially flows subsurface. The amount of surface flow is shown relative to a boot. Photo taken approximately 550 m upstream of Hwy 99. October 25, 2011.

This tributary drains the steep slopes bordering the Furry Creek Forest Service Road at the southern end of the property. The drainage was partially subsurface flowing under large boulders (Photo 27). The drainage is small with a channel width of 3.5 m and a wetted width of 1.7 m measured on October 25, 2011. The average gradient was 29 % with dominant substrate of boulder and gravel subdominant. Riparian vegetation is mature mixed forest. Due to the steep gradient and the morphology of the drainage (i.e., partially subsurface), the drainage is not considered fish habitat.

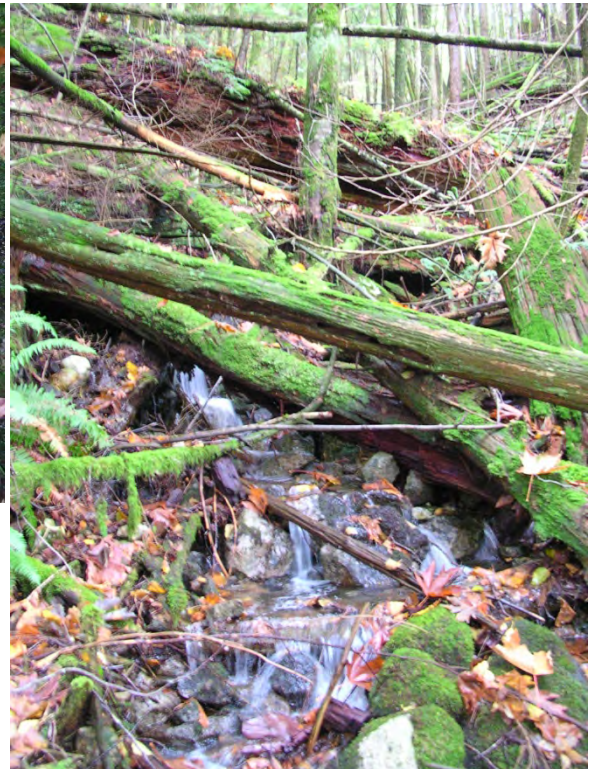
Photo 28: View of drainage 7 facing upstream. Photo taken upstream of the confluence with drainage 6. November 1, 2011.

This tributary drains the southernmost portion of the property. The average channel width is 7.0 m with a wetted width of 4.4 measured on November 1, 2011. The drainage is steep with an average gradient of 33 %. Dominant substrate is cobble with lesser amounts of gravel (Photo 28). The drainage flows through a young coniferous forest. Due to the steep gradient of the drainage, this drainage is not considered fish habitat.

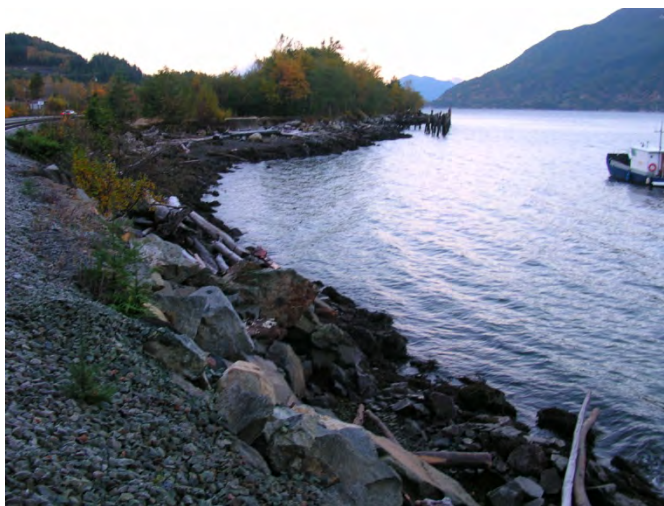
Photo 29: View of shorezone unit A from the northern property boundary facing south. Photo taken at 08:31, November 4, 2011.

The shoreline in shorezone unit A has experienced the highest level of disturbance (Photo 29-34). It is closest to Britannia Creek and the historic tailing disposal site, and was the site of a wharf used during the operation of the aggregates mine that existed at South Britannia Beach. The wharf presence is evidenced by old creosote-treated wooden pilings along the foreshore. Substrate in this section is dominated by imported riprap rock used for bank/shoreline retention, in addition to wooden planks and logs. Soil erosion upslope from the high intertidal zone is characteristic along this unit, as well as the presence of concrete and trash. Intertidal biodiversity is very low, supporting rockweed (*Fucus gardneri*), and acorn barnacle (*Balanus spp.*), without much sign of any other species.

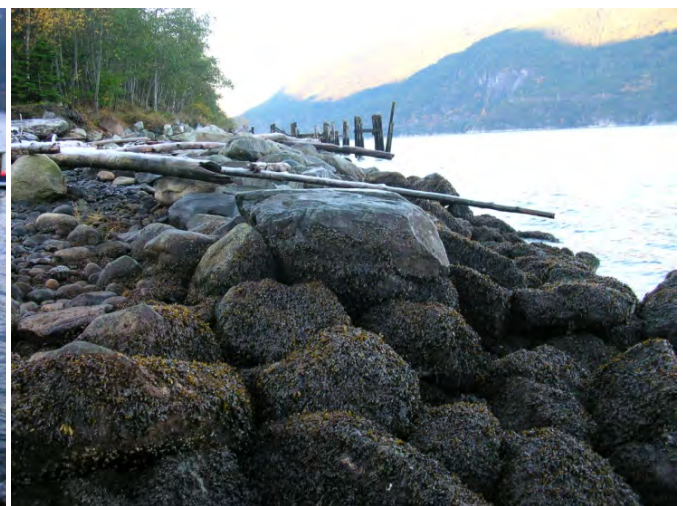
Photo 30: View of the old wharf facing south within shorezone unit A, November 4, 2011.

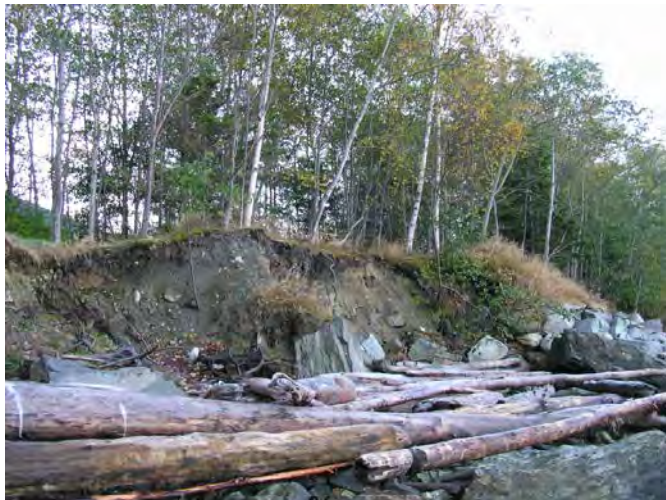
Photo 31: Eroded soil above the intertidal zone, shorezone unit A, November 4, 2011.

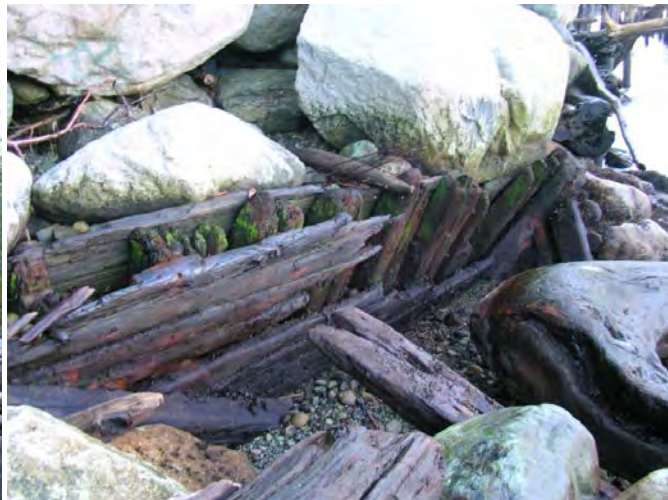
Photo 32: Anthropogenic alterations to the foreshore in shorezone unit A, November 4, 2011.

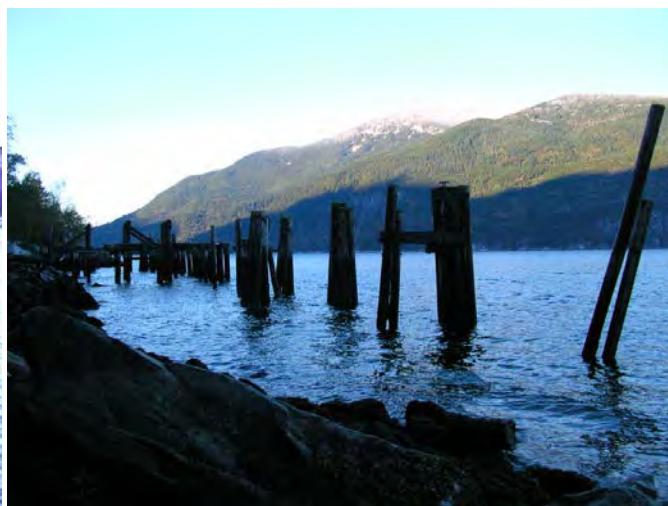
Photo 34: View of the old wharf pilings facing south, shorezone unit A, November 4, 2011.

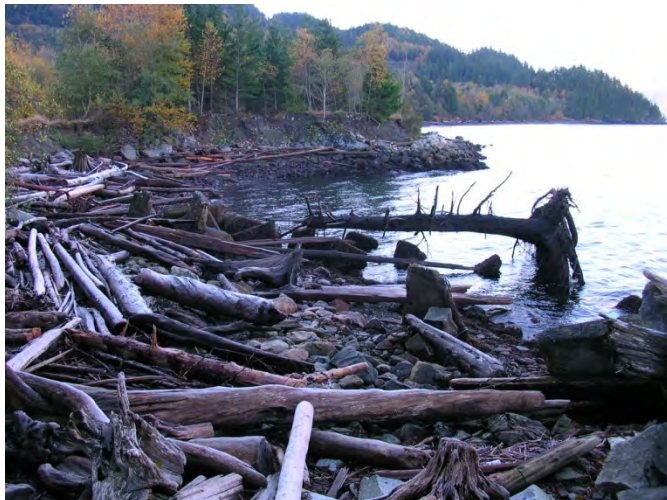
Photo 35: View facing south from the northern boundary of shorezone unit B, November 4, 2011.

Shorezone unit B is also disturbed although to a lesser degree. Substrate is composed of angular cobble sized rock and is likely imported. The substrate is smaller than the boulders in shorezone unit A. A large number of logs have floated into a small bay creating a physically complex intertidal zone (Photo 35). Soil erosion is significant above the high intertidal zone and has resulted in near vertical or undercut banks (Photo 36). Rockweed was the only algae species observed within this unit. Acorn barnacles and a dead Dungeness crab (*Cancer magister*) were observed in this unit.

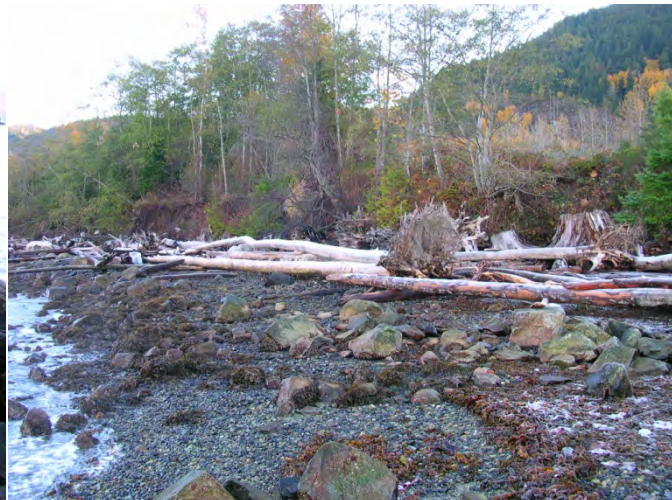
Photo 36: View facing upstream at the southern boundary of shorezone unit B. Bank erosion persists through this shorezone unit, November 4, 2011.

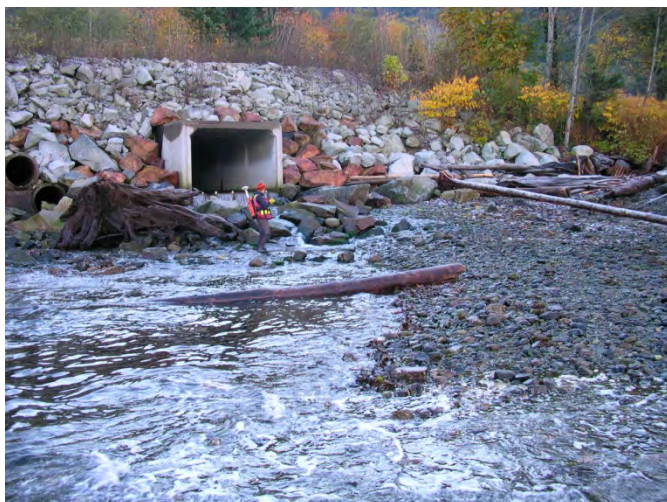
Photo 37: Thistle Creek marks the northern boundary of shorezone unit C along the foreshore, November 4, 2011.

The inflow of Thistle Creek marks the northern limit of shorezone unit C (Photo 37). This shorezone unit is characterized as having native gravel shore substrate and extends further into Howe Sound than shorezone units A and B. Healthy coniferous vegetation grows at the boundary between the intertidal and uplands zones in addition to woody debris dispersed on the upper intertidal (Photo 38). Daisy Creek flows into the sound immediately north of Minaty Bay. An old concrete boat launch exists at Minaty Bay (Photo 39). A bedrock outcrop interrupts the gravel shoreline and creates the pebble beach of Minaty Bay (Photo 40).

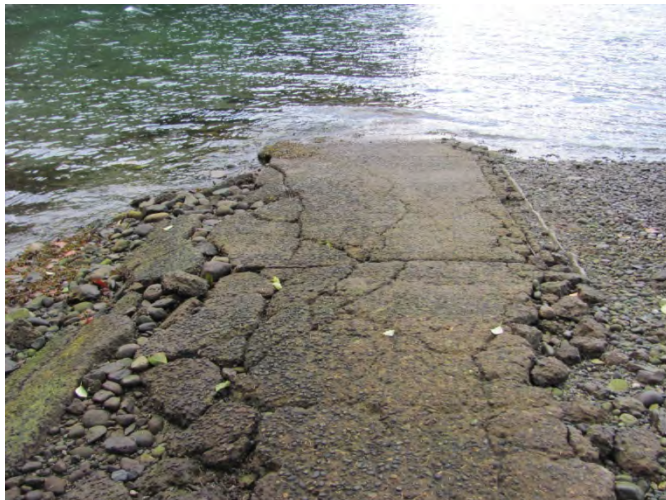
Photo 39: Concrete boat launch into Minaty Bay, November 4, 2011.

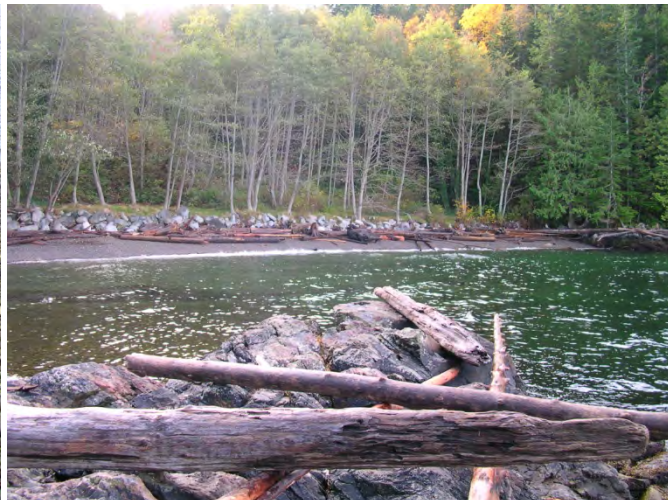
Photo 40: Minaty Bay is a pebble beach contained by rocky outcrops of both the north and southern beach boundaries, November 4, 2011.

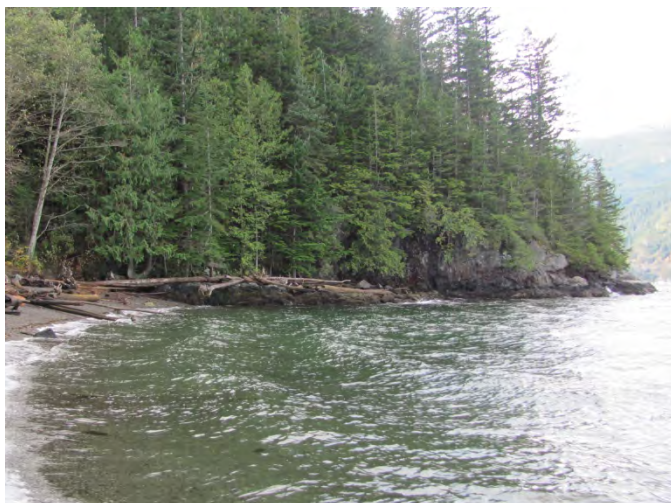
Photo 41: View of shorezone unit D facing south from Minaty Bay, November 4, 2011.

Shorezone unit D spans from the south side of Minaty Beach to the southern property boundary (Photo 41; Map 3). The shorezone unit is characterized by forested bedrock cliffs that rise sharply out of the ocean with rocky benches and small tide pools at the water's edge. Coniferous forest begins at the high tide level and extends up the rocky cliff. Shorezone unit D was not inventoried due to the difficult access along the rocky cliffs.

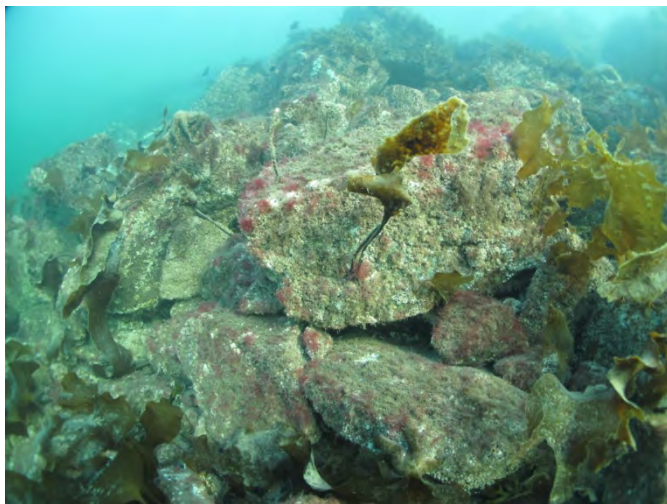
Photo 42: Riprap in Area 1 provides recruitment opportunities for algae and invertebrates, December 2, 2011. Photo by Balanced.

Biological conditions varied with elevation and substrate type. The intertidal riprap was colonized by biota commonly found within Howe Sound including barnacles (*Balanus glandula*), sea lettuce (*Ulva sp.*), seastars (*Evasterias troschelii*) and rockweed (*Fucus sp.*). Sugar wrack kelp (*Laminaria saccharina*) was observed attached to rocks, boulders, logs and anthropogenic materials near the low water mark. Crabs (*Cancer sp.*), sea stars (*Pycnopodia helianthoides*) and empty cockle clam shells (*Clinocardium nuttallii*) were observed on the mud seabed. The density of most organisms was sparse, especially where woody debris was present. Striped seaperch (*Embiotoca lateralis*) were abundant near the sunken vessels.

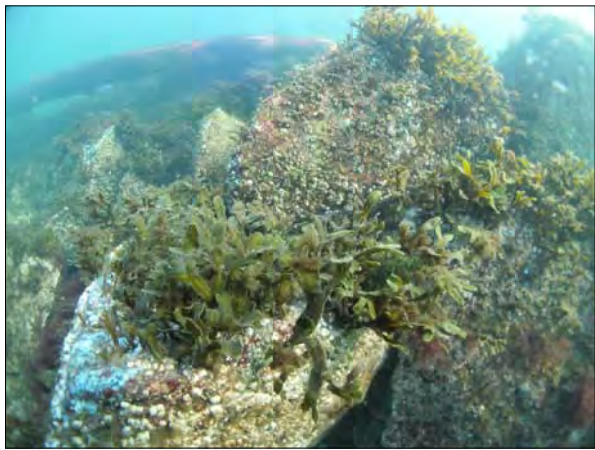
Photo 1. Typical intertidal riprap at Station 1 colonized by a variety of biota including rockweed, barnacles, and red rock crust (*Hildenbrandia* and/or *Mastocarpus spp.*).

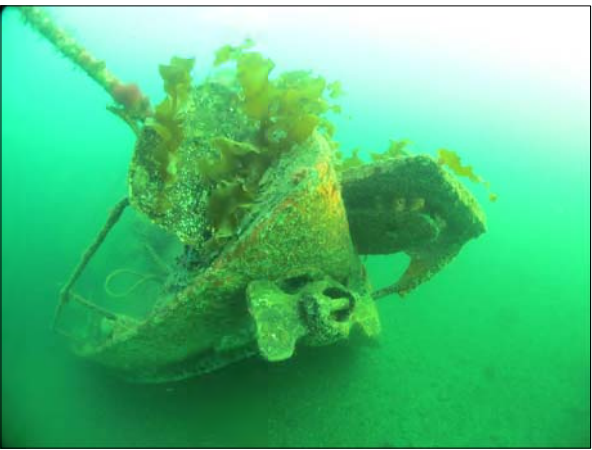
Photo 4. One of two sunken vessels observed in the vicinity of Station 2.
