BRITANNIA BEACH SOUTH  
SITE DEVELOPMENT AND SERVICING  
**VOL 5 OF 5 - REFERENCES**

# Britannia Beach South

## Site Development and Servicing

### Vol 5 of 5 – References

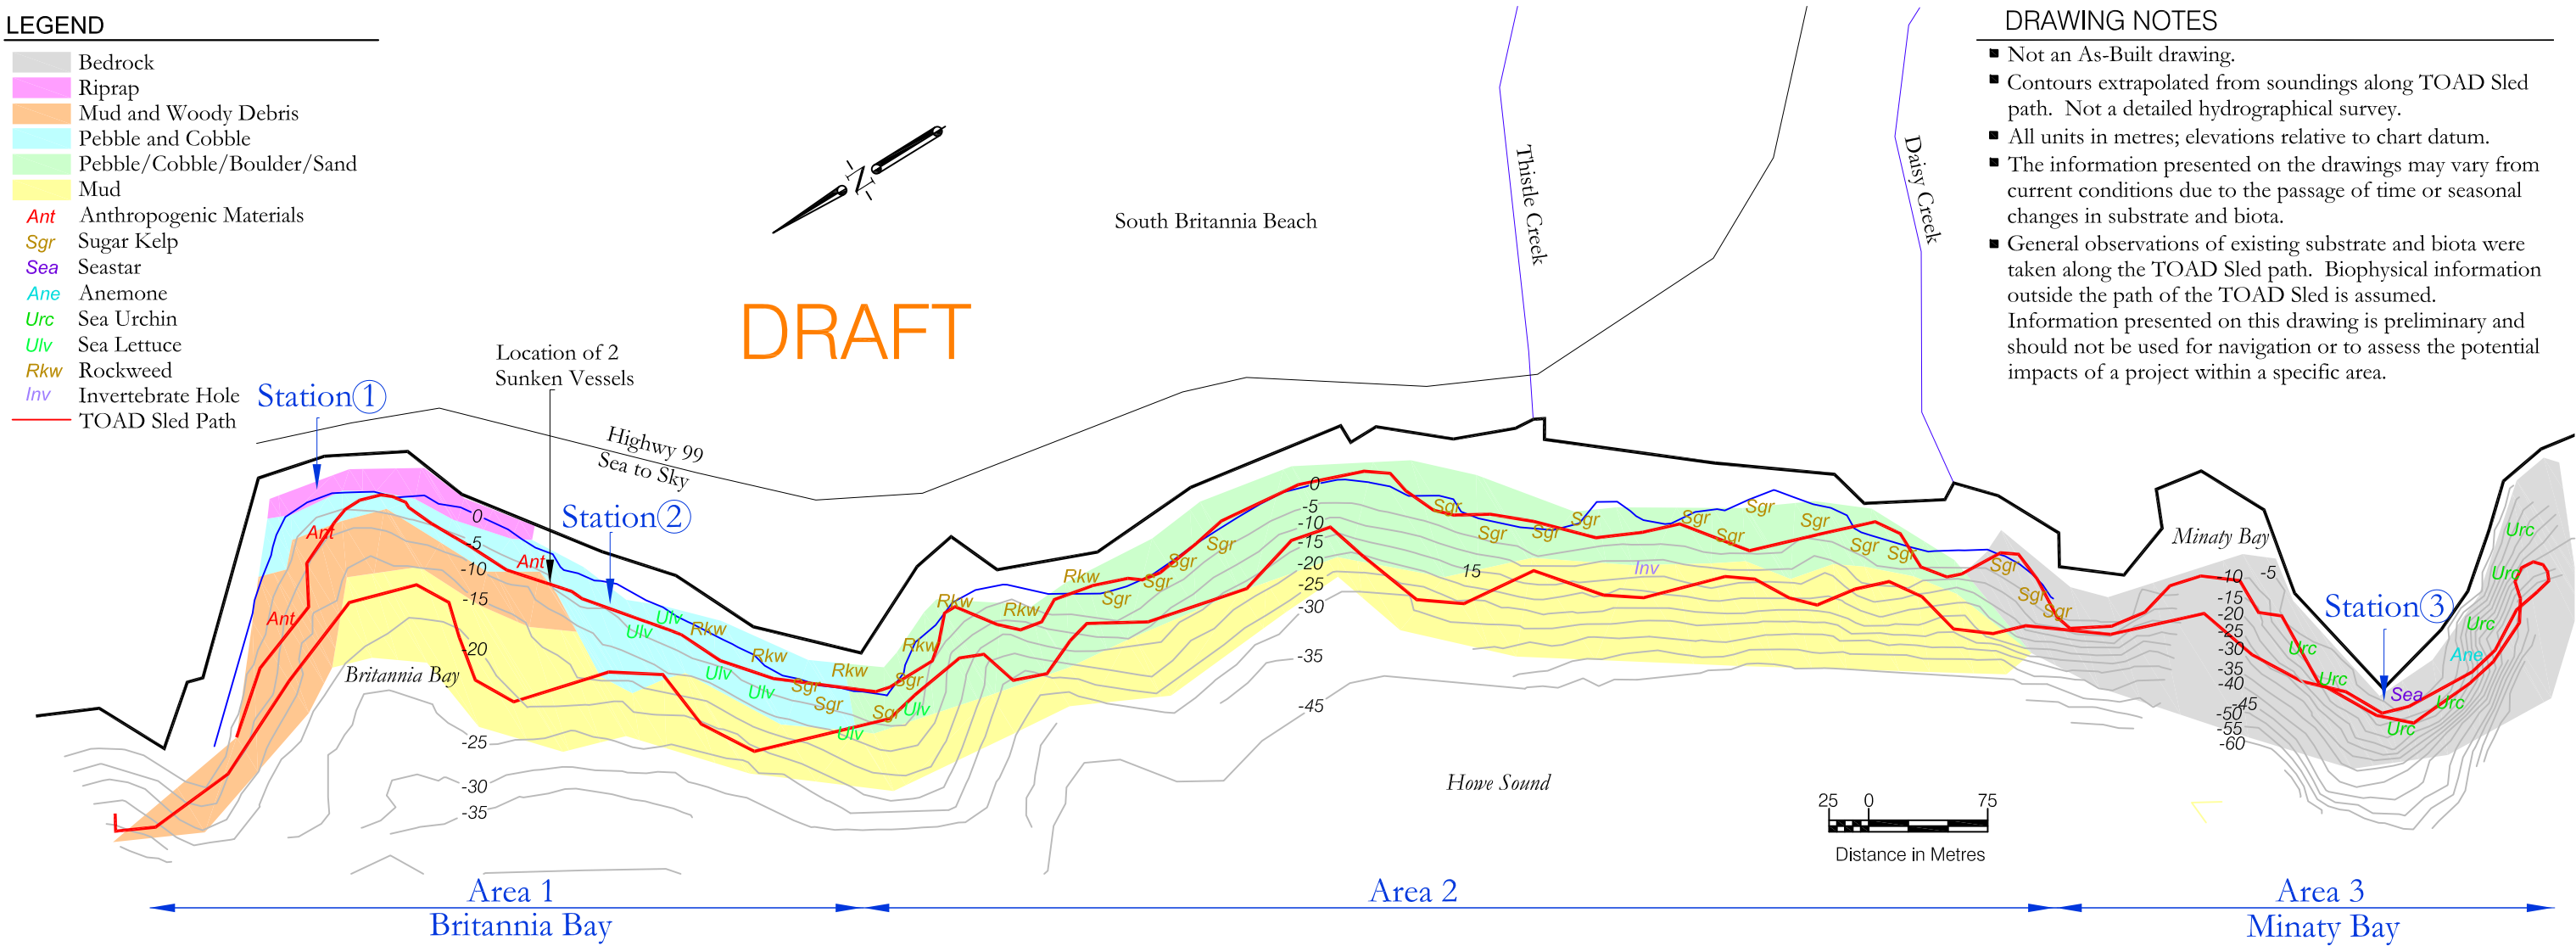
- Not an As-Built drawing.
- Contours extrapolated from soundings along TOAD Sled path. Not a detailed hydrographical survey.
- All units in metres; elevations relative to chart datum.
- The information presented on the drawings may vary from current conditions due to the passage of time or seasonal changes in substrate and biota.
- General observations of existing substrate and biota were taken along the TOAD Sled path. Biophysical information outside the path of the TOAD Sled is assumed. Information presented on this drawing is preliminary and should not be used for navigation or to assess the potential impacts of a project within a specific area.

Preliminary hydrographic data was collected from the dive boat's digital depth sounder and GPS during the two TOAD Sled transects. This data was used to generate preliminary contours describing the depth and slope of the seabed within the survey area.

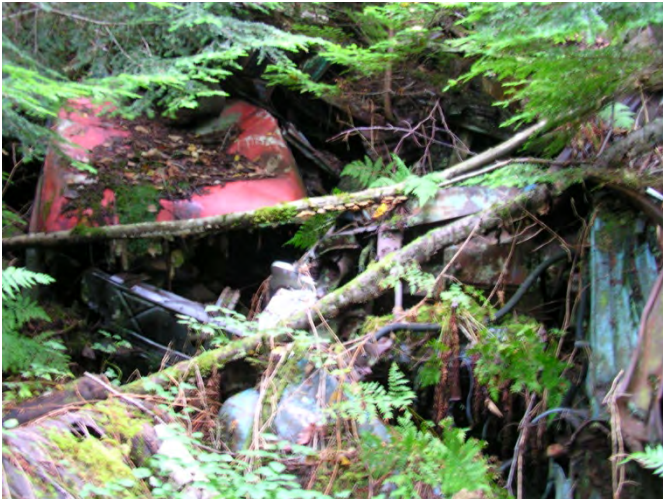
Photo 56: Waste heap in DL 2001 and 7053 containing automobiles and other scrap metal. November 1, 2011

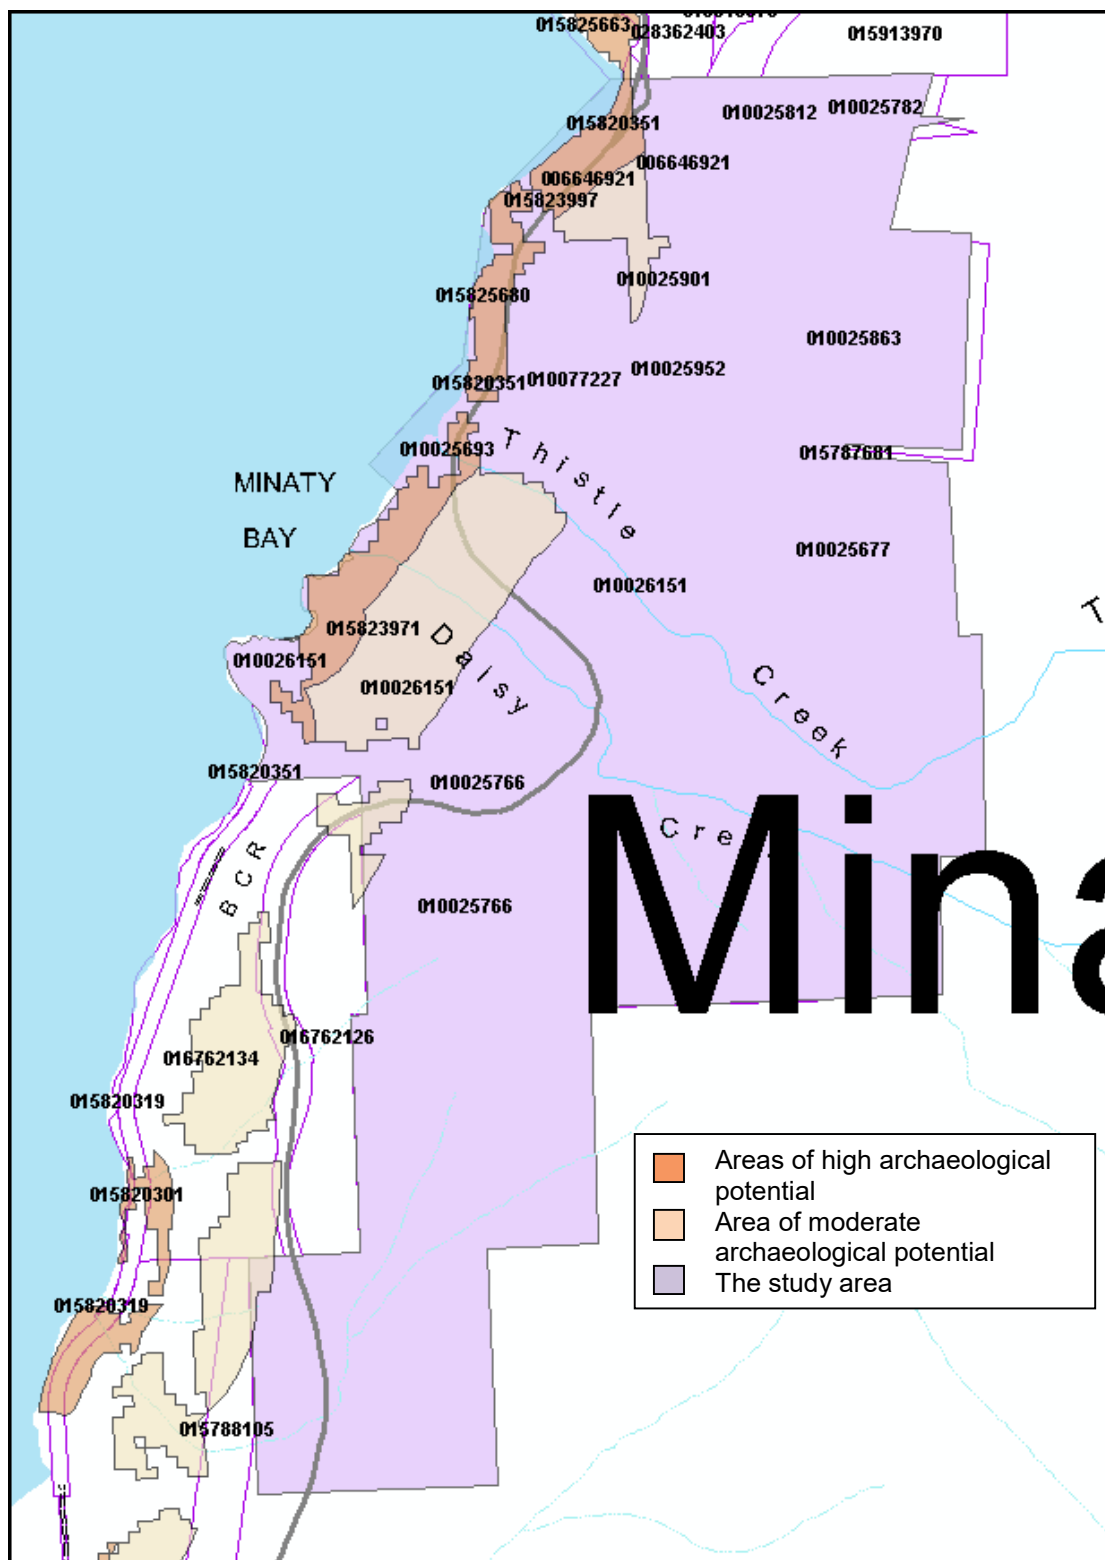
Figure 2: Archaeological potential mapping of South Britannia Beach provided by the Archaeological Branch of the MFLNRO upon request for archaeological site information.

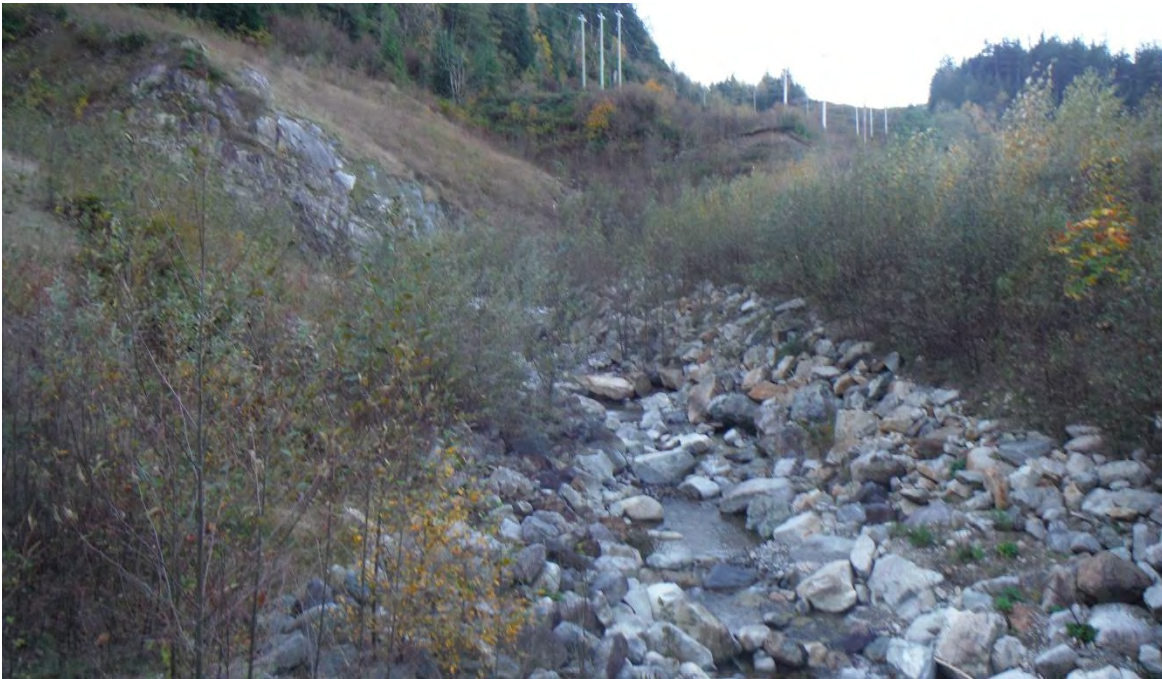
Currently there is a debris basin constructed on Daisy Creek just upstream of Highway 99 as shown in Photo 1 and 2.

Photo 1: Debris Basin Looking Upstream from Spillway October 16, 2015

The Daisy Creek debris basin was constructed as part of the upgrade to Highway 99 completed prior to 2010. The basin was specifically designed to protect Highway 99 but offers some protection to the proposed development. The Ministry of Transportation and Infrastructure (MoTI) is currently responsible for operations and maintenance of the basin.

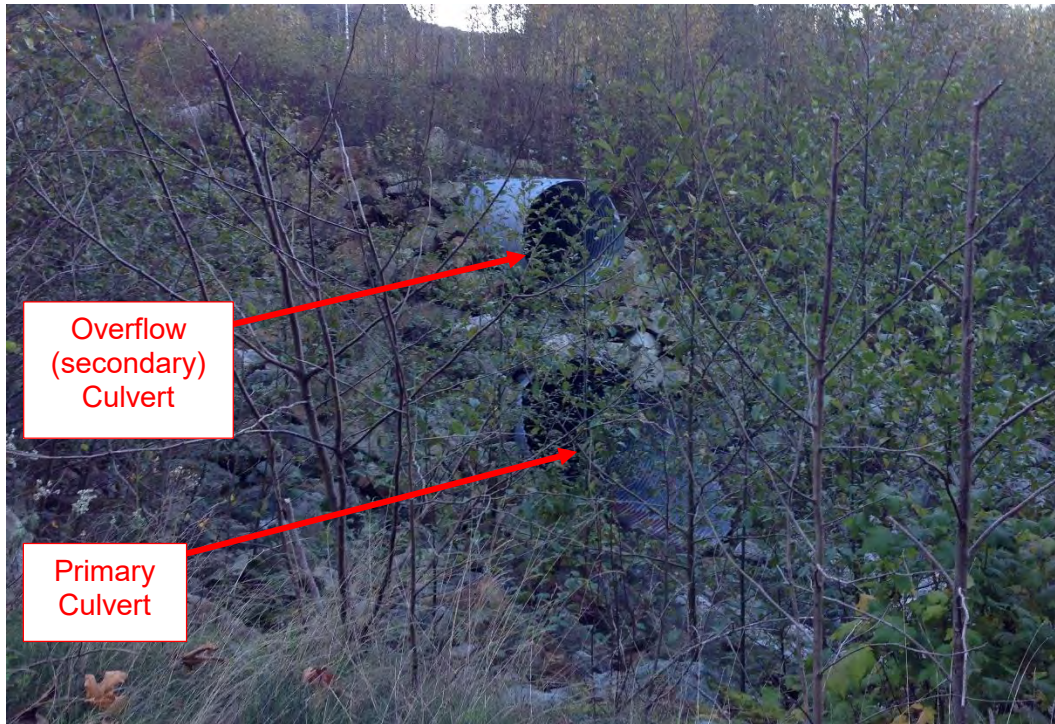
Photo 2: Daisy Creek Debris Basin Culvert Outlet
